# Draft Fluvial Geomorphology and Meander Beltwidth Assessment

August 14, 2021  
WE 20030

**RE: Park Lawn GO Station Fluvial Geomorphic and Erosion Rate Assessment  
Toronto, Ontario**

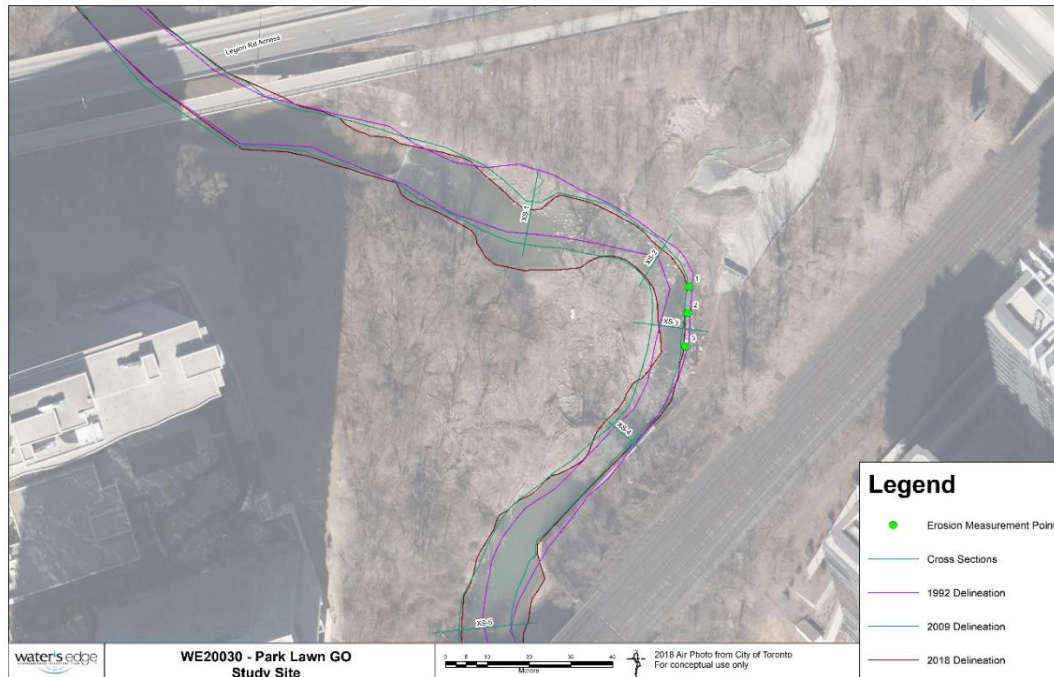
**Figure 1:** Study site showing Mimico Creek extending from the Gardiner Expressway to the railway line.

Measurement points were selected based on where active erosion was observed on the meander bend that is of greatest concern to the development of the GO Station. In addition, this bank is where active erosion was noted, and it is where infrastructure has been constructed to protect the bank (**Figure 1**). The results from these measurements can be seen in **Table 6**. This 100 year erosion rate is for a natural creek with no retaining wall or gabion basket.

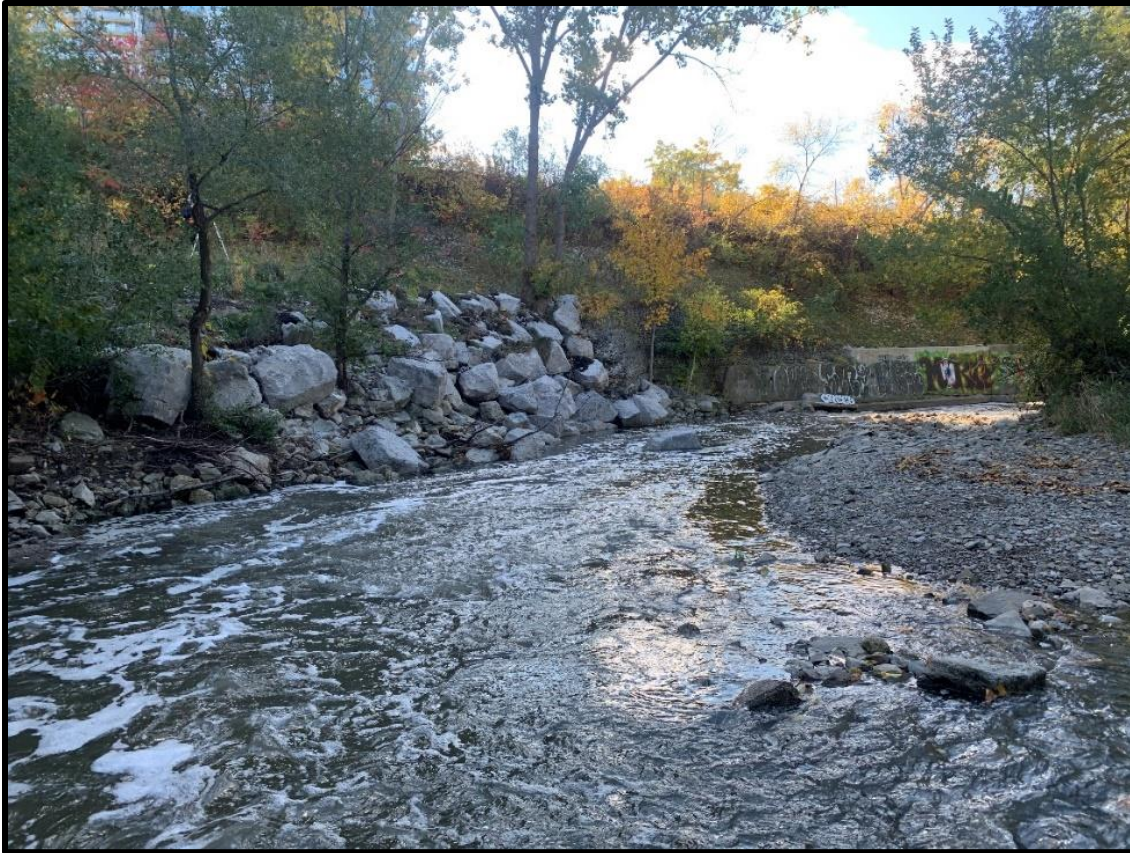
Downstream from this scour pool the channel exhibits regular riffle-pool sequences. These cascade down to where the east bank has been armoured at the meander bend. The bend has been protected using large pieces of armourstone that have since slumped and begun falling into the creek (**Figure 3**). Downstream from the armourstone bank protection, further bank and slope protection consist of a short section of gabion basket wall and longer section of concrete retaining wall. While these walls appear to be in good condition with little to no outflanking from fluvial processes, a deep scour pool has formed directly adjacent to the concrete wall. While this does not appear to have undercut the wall, it is imperative that it is monitored as the existing slope stability is dependent on that wall. Downstream from the wall, the watercourse widens and shallows, transitioning into the conditions found downstream from the railway bridge.

**Figure 3:** Looking downstream at the armoured bank. Slumping armourstone protects the bend, and the gabion basket and concrete retaining walls can be seen protecting the slope. Note that there are scour pools directly adjacent to the concrete wall.

Mimico Creek was assessed as “Transitional” due to the erosion found on the east bank and in the scour pool, alongside the slumping armourstone.

1. Continue to maintain the existing gabion basket and concrete retaining walls and armourstone revetment; or,
2. Realign Mimico Creek away from the existing stabilization infrastructure into the wooded area.

It is recommended that the first solution is better for both the health of the creek and to avoid disturbing a natural area in what is otherwise a highly urbanized environment. In addition, there is limited space to work with to the west of the watercourse as there are several condo towers that require consideration in any movement of Mimico Creek. However, it is critical that the retaining walls are inspected regularly and repaired as required based on inspection results. If the walls are left to weaken, it could result in significant erosion and damage to the rail line during a high discharge event.
