# **Fluvial Geomorphology and Meander Beltwidth Assessment**

August 14, 2021  
WE 20030

**RE: Park Lawn GO Station Fluvial Geomorphic and Erosion Rate Assessment  
Toronto, Ontario**

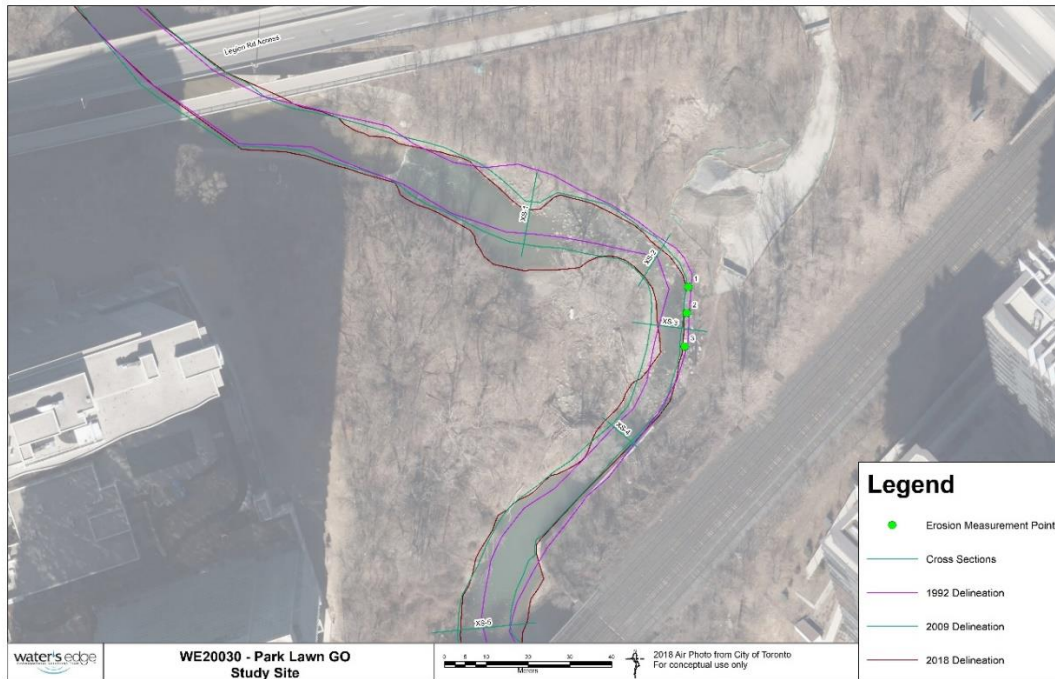
**Figure 1:** Study site showing Mimico Creek extending from the Gardiner Expressway to the railway line.

Air photos from 1992, 2009 and 2018 were analyzed for changes in stream planform using GIS mapping where the photos were used to delineate the bankfull limits of the channel which the meander axis and beltwidths are based on. The historic air photos were used to provide a reasonable representation for how the river has adjusted in the past 28 years. The bankfull delineations can be seen in **Figure 1**.

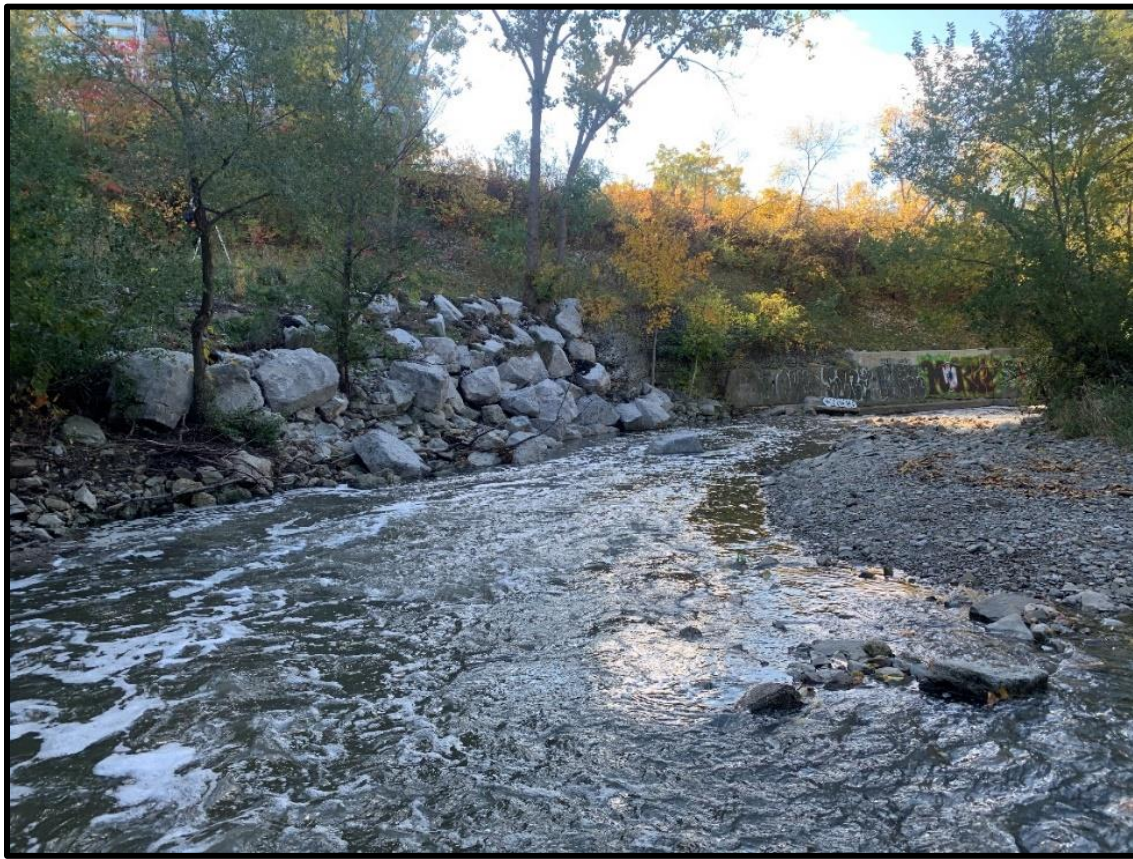
**Figure 3:** Looking downstream at the armoured bank. Slumping armourstone protects the bend, and the gabion basket and concrete retaining walls can be seen protecting the slope. Note that there are scour pools directly adjacent to the concrete wall.

Mimico Creek was assessed as “Transitional” due to the erosion found on the east bank and in the scour pool, alongside the slumping armourstone.

1. Continue to maintain the existing gabion basket and concrete retaining walls and armourstone revetment; or,
2. Realign Mimico Creek away from the existing stabilization infrastructure into the wooded area.

It is recommended that the first solution is better for both the health of the creek and to avoid disturbing a natural area in what is otherwise a highly urbanized environment. In addition, there is limited space to work with to the west of the watercourse as there are several condo towers that require consideration in any movement of Mimico Creek. However, it is critical that the retaining walls are inspected regularly and repaired as required based on inspection results. If the walls are left to weaken, it could result in significant erosion and damage to the rail line during a high discharge event.
