APPENDIX I Slope Stability Analysis

Lakeshore Development Inc. Park Lawn GO

Slope Stability Analysis

Lakeshore Development Inc. - Park Lawn GO Slope Stability Analysis

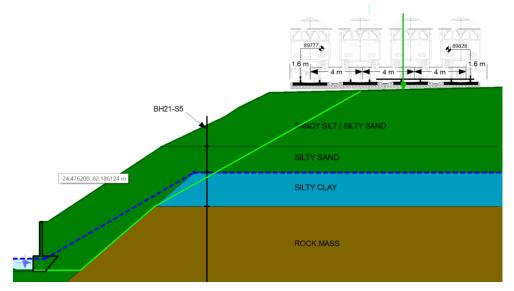
Figure 4-1: Estimated LTSTOS for Section A-A' based on the Graphical Method with the Vertical Arrow Indicating the LTSTOS based on the Slope Stability Model

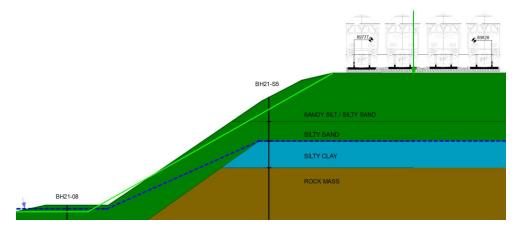
Figure 4-2: Estimated LTSTOS for Section B-B' based on the Graphical Method with the Vertical Arrow Indicating the LTSTOS based on the Slope Stability Model

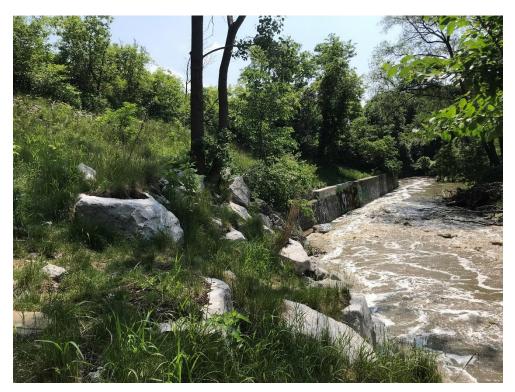
Photograph 1: View of Existing Erosion Protection measures and retaining wall at the toe of the embankment slope at the west end of the site (Looking West towards Mimico Creek Bridge).

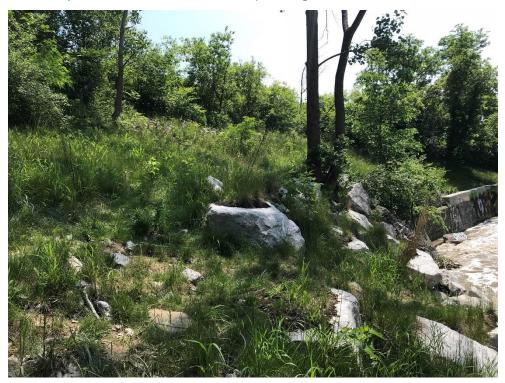
Photograph 2: View of slope condition and rip-rap protection East of the existing retaining wall

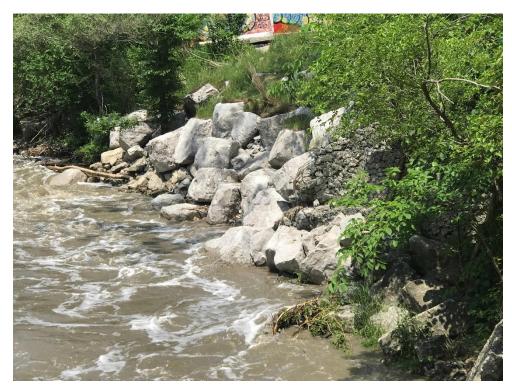
Photograph 3: Close up view existing Gabion Basket wall and Rip-Rap at the toe of the embankment Slope transitioning north (away from the embankment)

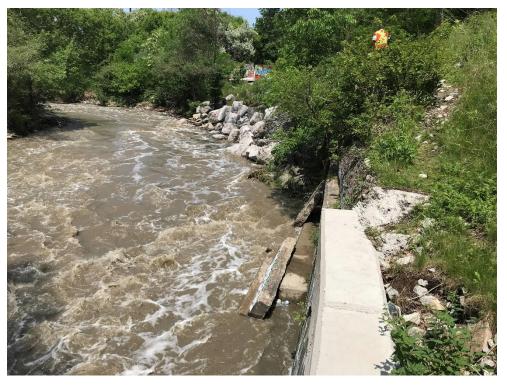
Photograph 4: View of the erosion protection measures looking East towards Park Lawn Rd.

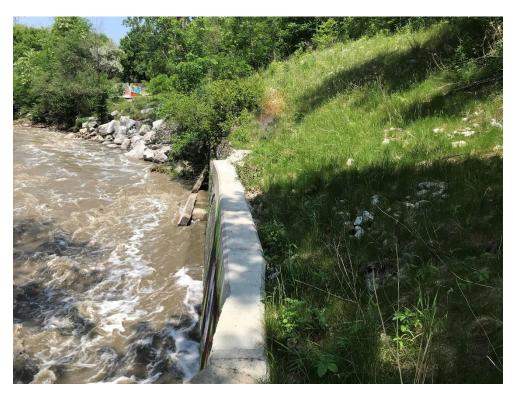
Photograph 5: Photograph 4: View of the erosion protection measures looking East towards Park Lawn Rd.

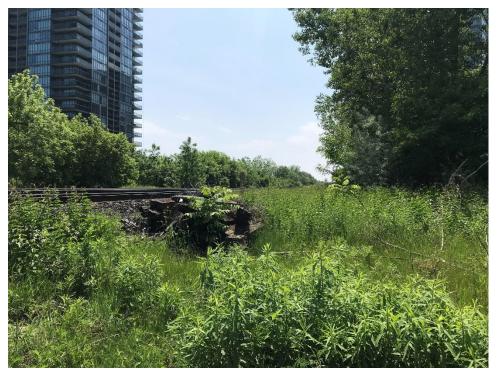
Photograph 6: View of from the top of rail embankment at the Park Lawn Road Bridge (Looking East towards Mimico Creek)

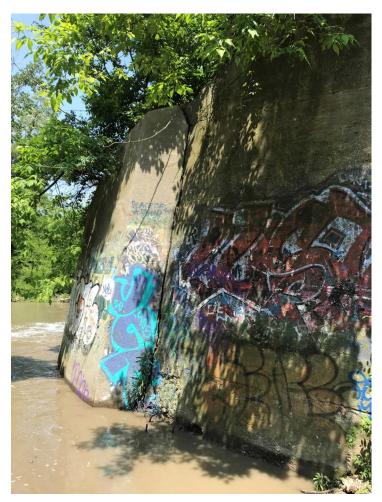
Photograph 7: View of the West End of the Existing Retaining wall at the Mimico Creek East Abutment
