Lakeshore Development Inc. Park Lawn GO

Slope Stability Analysis

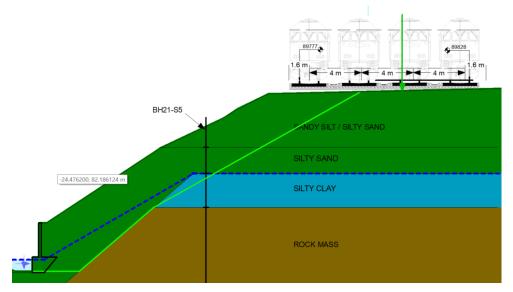
Figure 4-1: Estimated LTSTOS for Section A-A' based on the Graphical Method with the Vertical Arrow Indicating the LTSTOS based on the Slope Stability Model

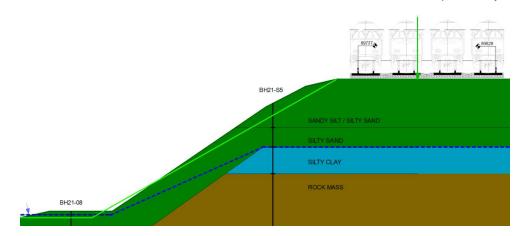
Figure 4-2: Estimated LTSTOS for Section B-B' based on the Graphical Method with the Vertical Arrow Indicating the LTSTOS based on the Slope Stability Model

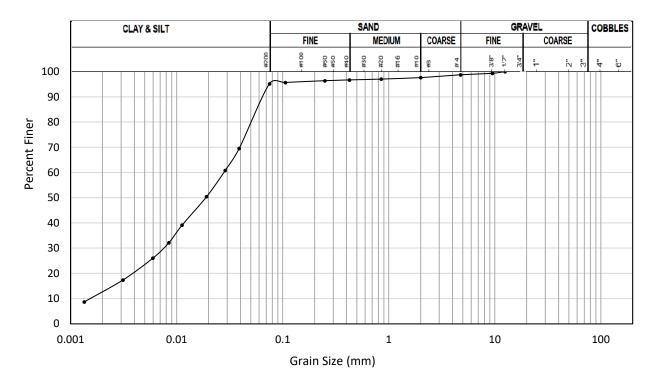
Comments: Material is shaley. Slakes after washing and drying.

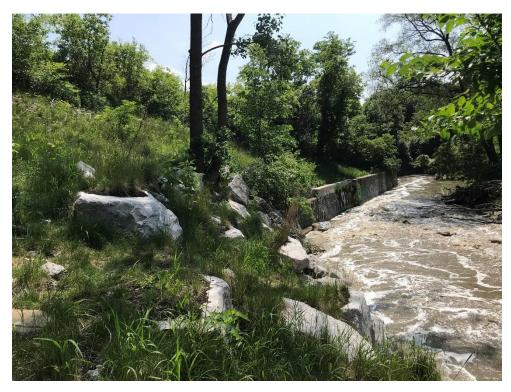
Photograph 1: View of Existing Erosion Protection measures and retaining wall at the toe of the embankment slope at the west end of the site (Looking West towards Mimico Creek Bridge).

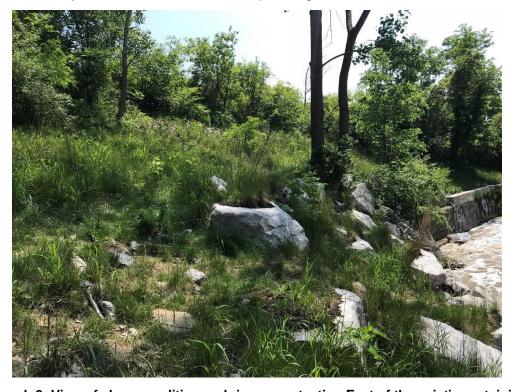
Photograph 2: View of slope condition and rip-rap protection East of the existing retaining wall

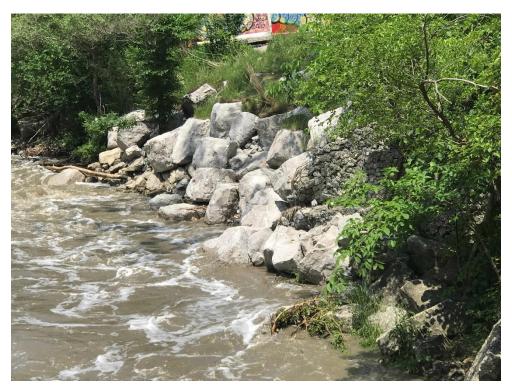
Photograph 3: Close up view existing Gabion Basket wall and Rip-Rap at the toe of the embankment Slope transitioning north (away from the embankment)

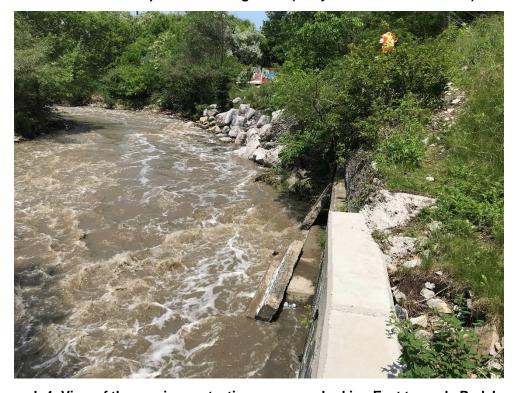
Photograph 4: View of the erosion protection measures looking East towards Park Lawn Rd.

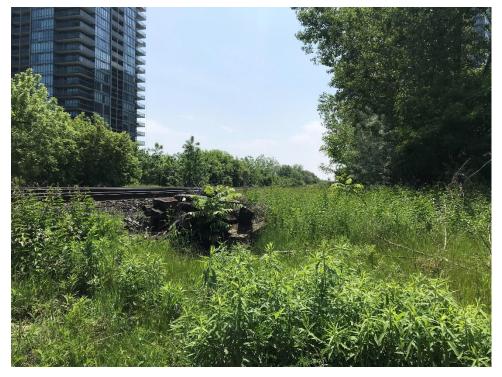
Photograph 6: View of from the top of rail embankment at the Park Lawn Road Bridge (Looking East towards Mimico Creek)

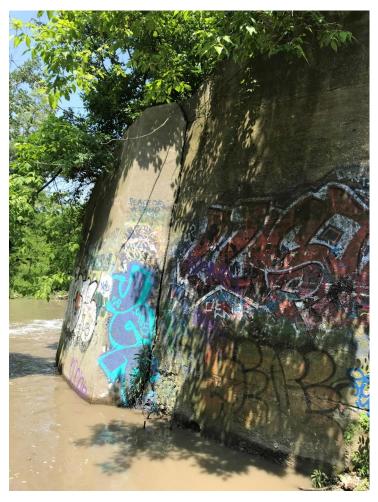
Photograph 7: View of the West End of the Existing Retaining wall at the Mimico Creek East Abutment
