APPENDIX J Fluvial Geomorphology and Meander Beltwidth Assessment

August 14, 2021 WE 20030

RE: Park Lawn GO Station Fluvial Geomorphic and Erosion Rate Assessment Toronto, Ontario

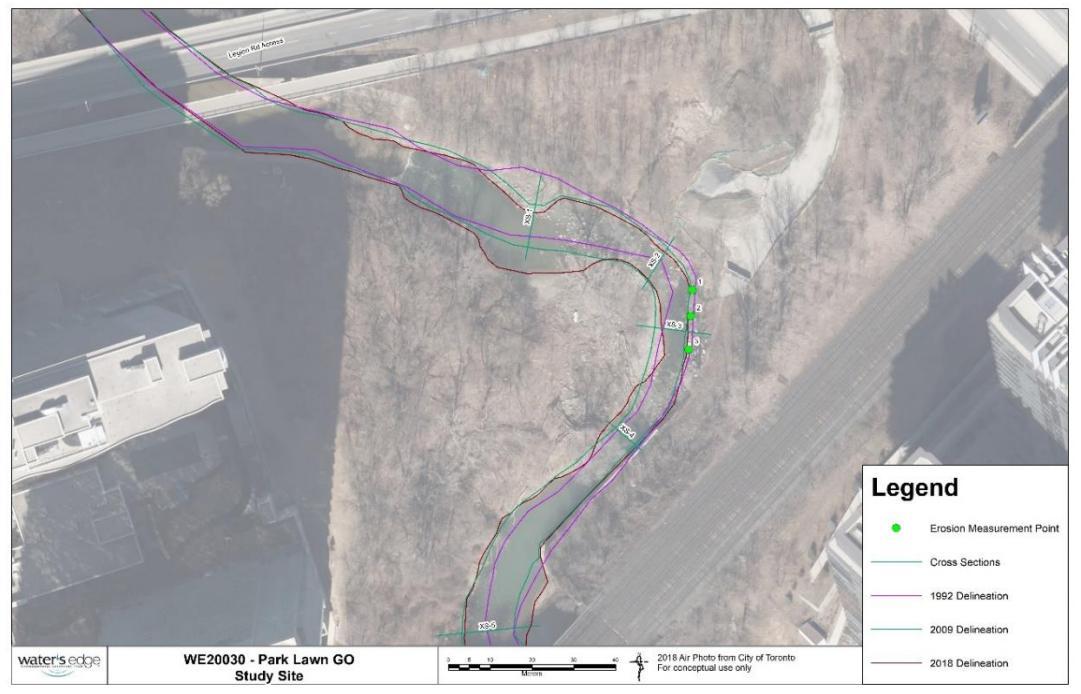
Figure 1: Study site showing Mimico Creek extending from the Gardiner Expressway to the railway line.

Measurement points were selected based on where active erosion was observed on the meander bend that is of greatest concern to the development of the GO Station. In addition, this bank is where active erosion was noted, and it is where infrastructure has been constructed to protect the bank (**Figure 1**). The results from these measurements can be seen in **Table 6**. This 100 year erosion rate is for a natural creek with no retaining wall or gabion basket.

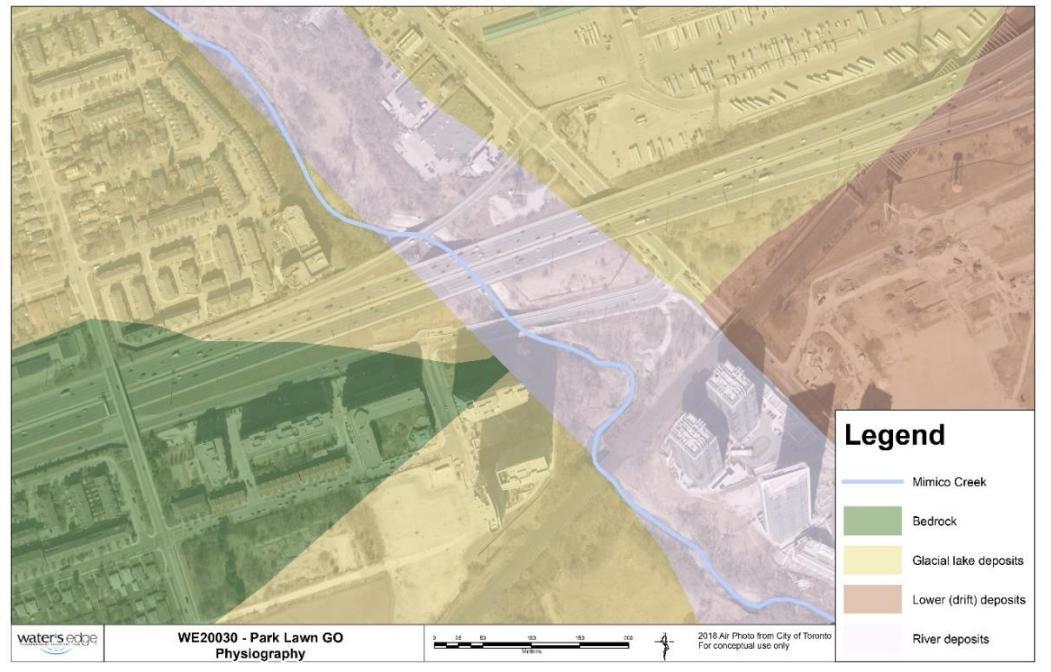
Reviewing the sites surficial materials is important to evaluate active channel processes. Stream channel form and sediment supply are controlled by the region's physiography and underlying surficial geology. The site is found in the Iroquois Plain and is predominated by modern alluvial deposits (**Figure 2**). This results in sediments that are predominated by gravels and cobbles. While this can result in a stable bed, it can make result in banks that are highly susceptible to erosion, especially when banks are steep.

Figure 2: Local physiography of the study site, found within the Iroquois Plain (Chapman & Putnam, 1984).

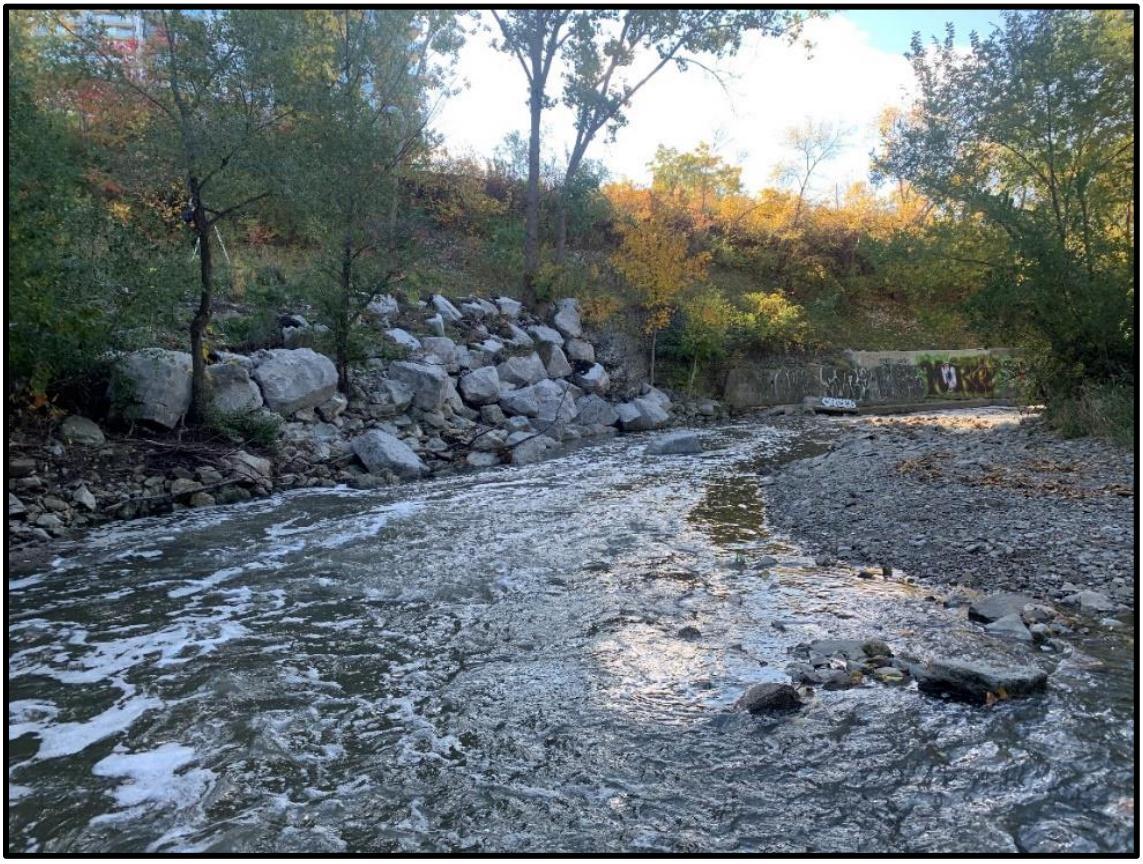
Downstream from this scour pool the channel exhibits regular riffle-pool sequences. These cascade down to where the east bank has been armoured at the meander bend. The bend has been protected using large pieces of armourstone that have since slumped and begun falling into the creek (**Figure 3**). Downstream from the armourstone bank protection, further bank and slope protection consist of a short section of gabion basket wall and longer section of concrete retaining wall. While these walls appear to be in good condition with little to no outflanking from fluvial processes, a deep scour pool has formed directly adjacent to the concrete wall. While this does not appear to have undercut the wall, it is imperative that it is monitored as the existing slope stability is dependent on that wall. Downstream from the wall, the watercourse widens and shallows, transitioning into the conditions found downstream from the railway bridge.

Figure 3: Looking downstream at the armoured bank. Slumping armourstone protects the bend, and the gabion basket and concrete retaining walls can be seen protecting the slope. Note that there are scour pools directly adjacent to the concrete wall.

- 1. Continue to maintain the existing gabion basket and concrete retaining walls and armourstone revetment; or,
- 2. Realign Mimico Creek away from the existing stabilization infrastructure into the wooded area.

It is recommended that the first solution is better for both the health of the creek and to avoid disturbing a natural area in what is otherwise a highly urbanized environment. In addition, there is limited space to work with to the west of the watercourse as there are several condo towers that require consideration in any movement of Mimico Creek. However, it is critical that the retaining walls are inspected regularly and repaired as required based on inspection results. If the walls are left to weaken, it could result in significant erosion and damage to the rail line during a high discharge event.
