## APPENDIX D Cultural Heritage Report

**Lakeshore Development Inc.  
Park Lawn GO Station**

**Cultural Heritage Report: Existing Conditions and Preliminary Impact  
Assessment**

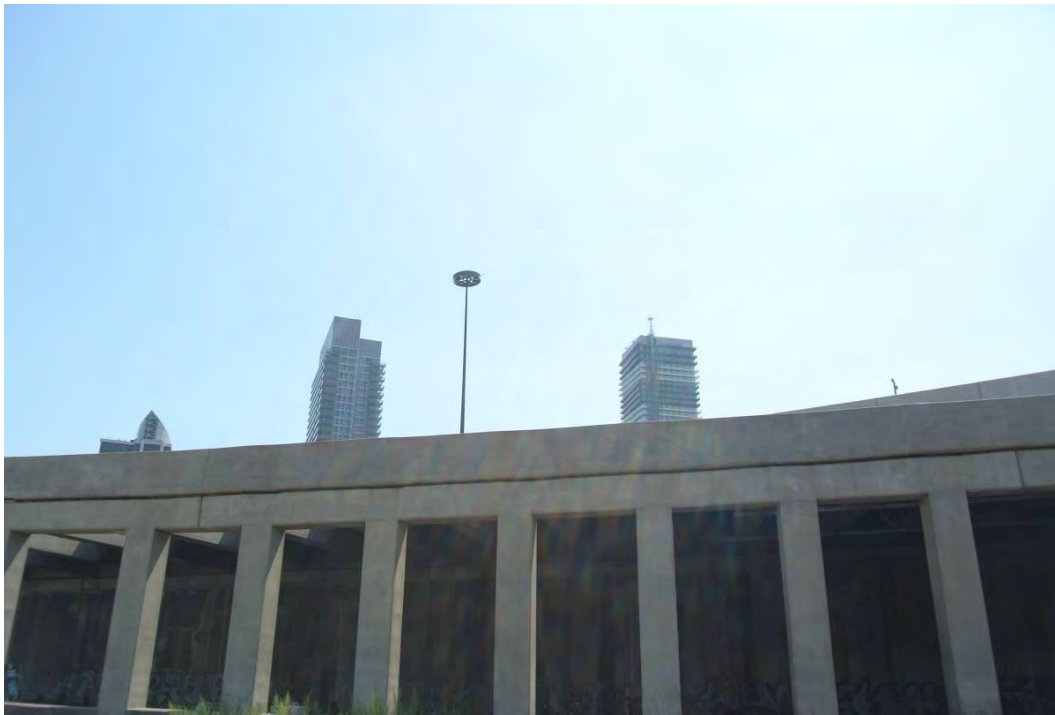
- the new water tower views that would be created; the prominence of these views is analyzed according to the seven criteria established in Section 2.2 of this report; and
- the way the new location measures against the eight Relocation Evaluation Criteria established in Section 2.4 of this report. The view analysis described above is applied to respond to the Relocation Evaluation Criteria 3-5.

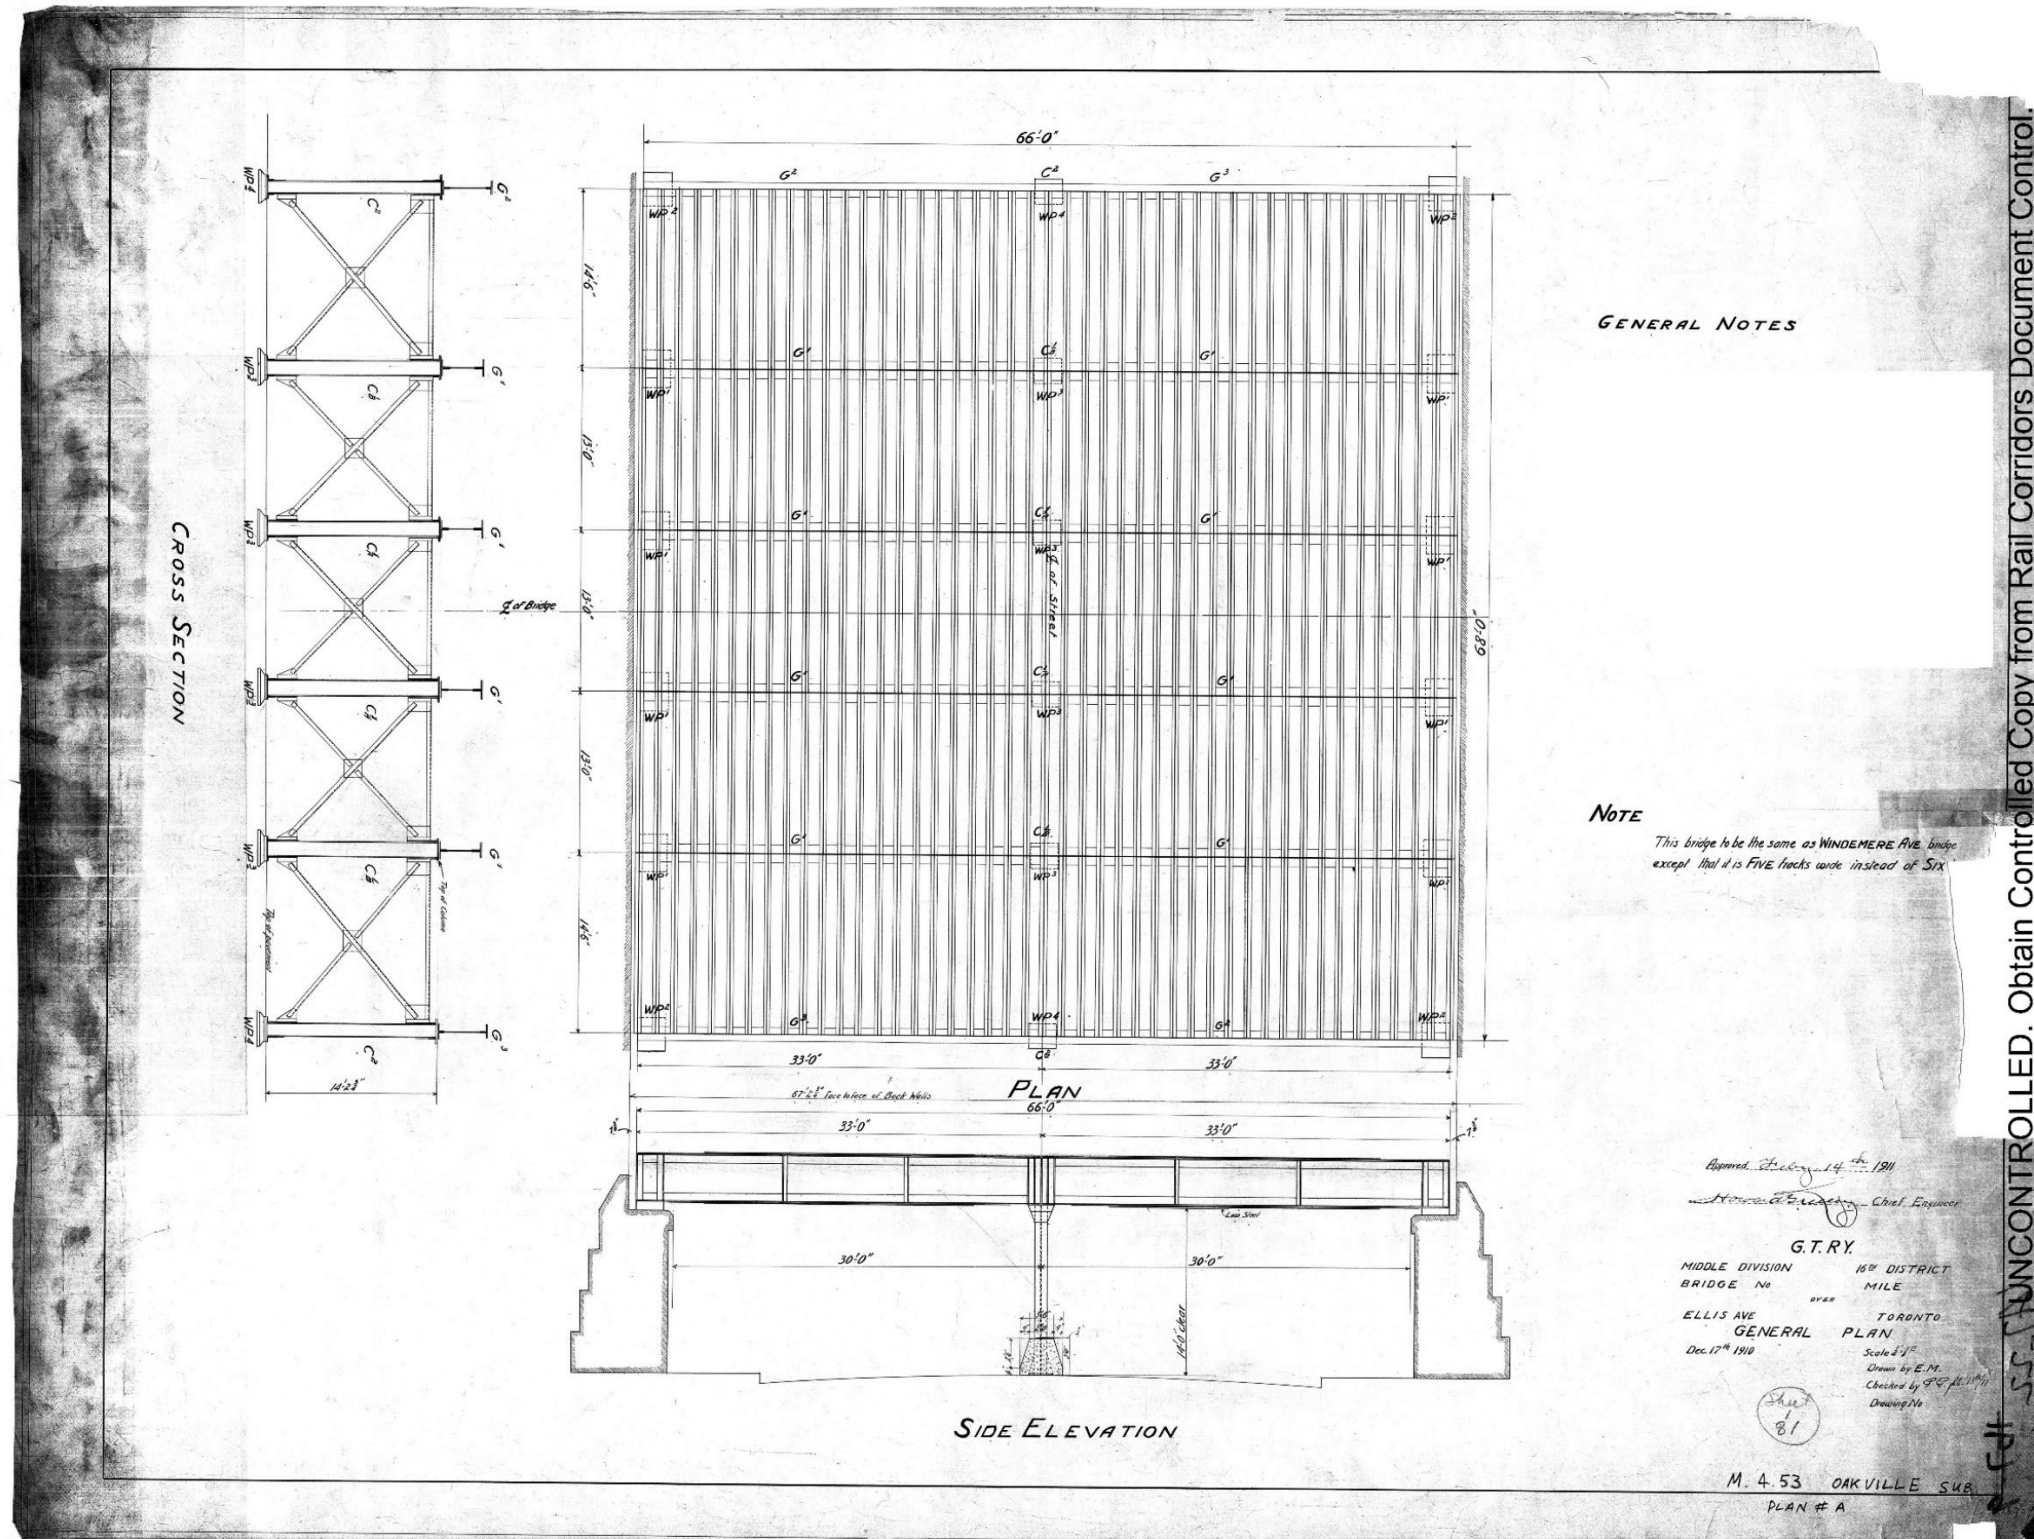
Figure 37: General plan for the Ellis Avenue Bridge (Mile 4.54) (Grand Trunk Railway 1910)

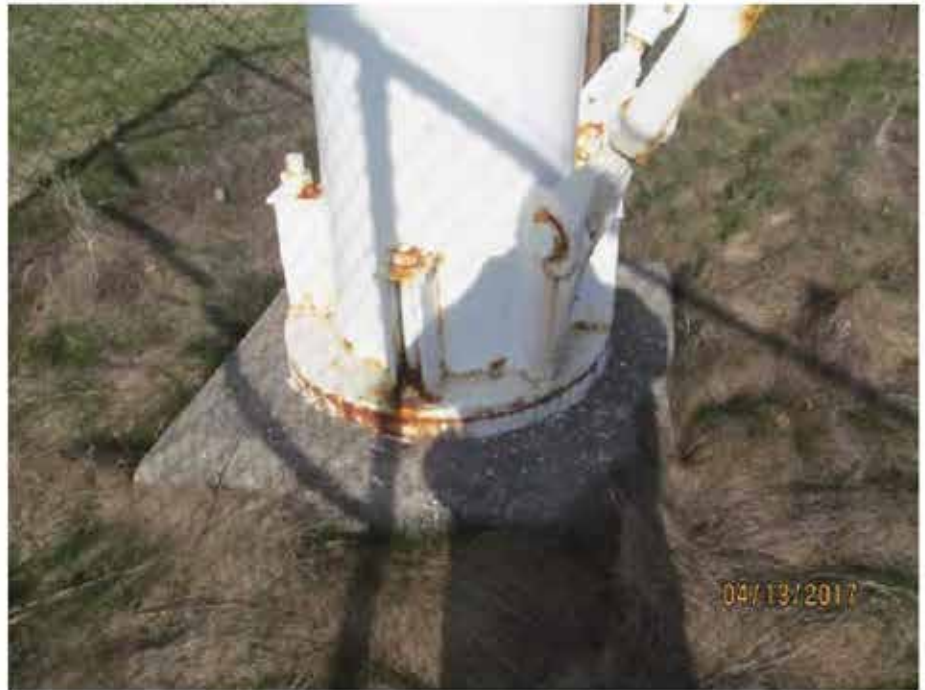
**PHOTOGRAPH NO. 1**

- ▶ Photo ID: CSE001
- ▶ Tower Leg
- ▶ April 13, 2017
- ▶ Problem: Corrosion at Base

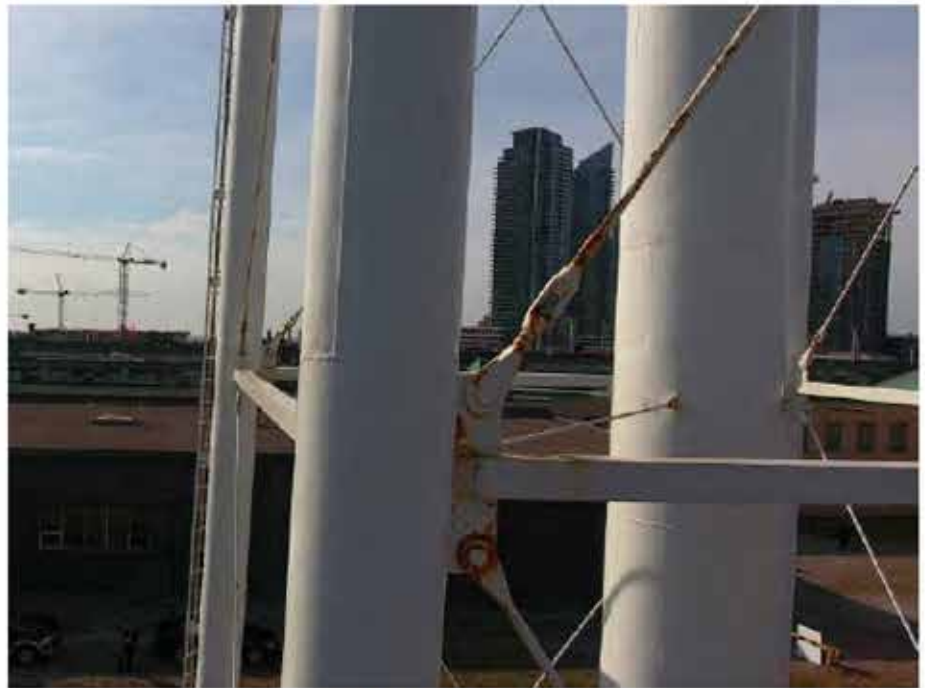
**PHOTOGRAPH NO. 2**

- ▶ Photo ID: CSE002
- ▶ Diagonal Brace
- ▶ April 13, 2017
- ▶ Problem: Corrosion on Turnbuckle and Gusset Plate

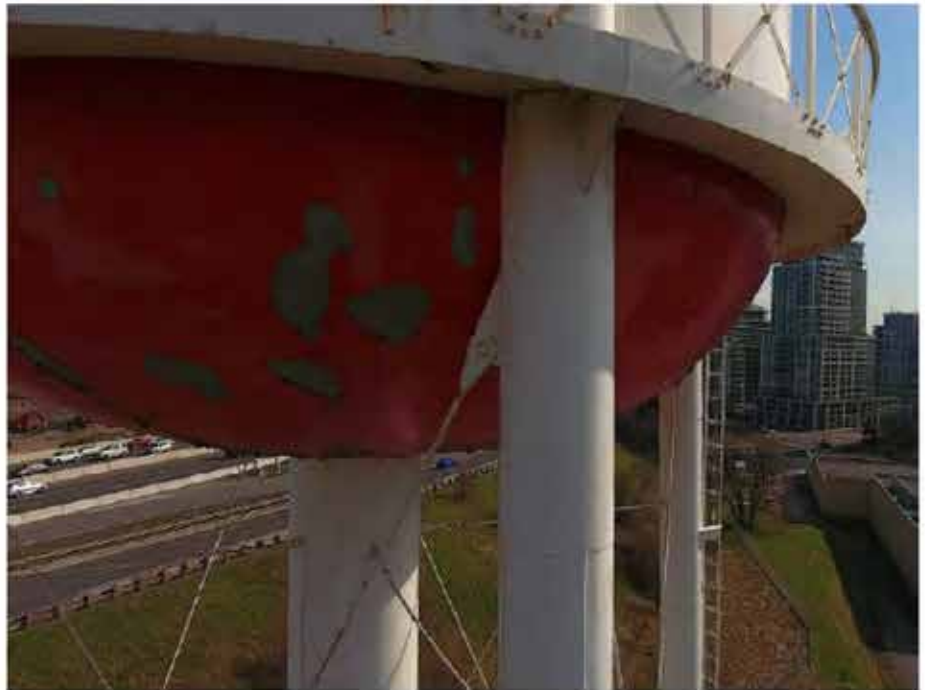
**PHOTOGRAPH NO. 3**

- ▶ **Photo ID: CSE003**
- ▶ **Diagonal Brace**
- ▶ **April 13, 2017**
- ▶ **Problem: Corrosion on Steel Rod (See Bottom of Photograph)**

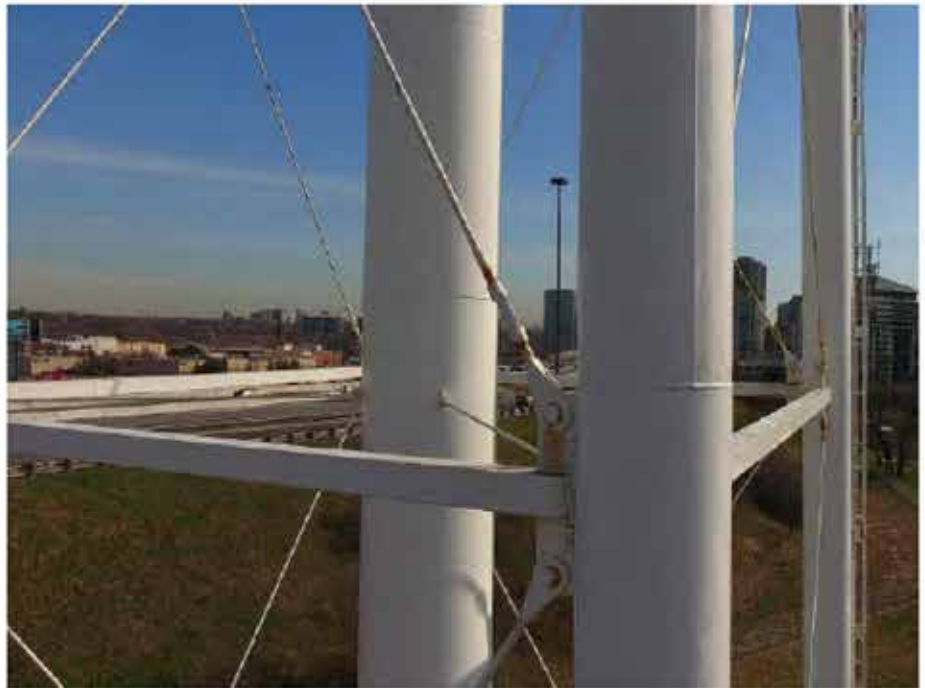
**PHOTOGRAPH NO. 4**

- ▶ **Photo ID: CSE004**
- ▶ **Horizontal Brace**
- ▶ **April 13, 2017**
- ▶ **Problem: HSS Typically in Good Condition. No Concerns Expressed.**

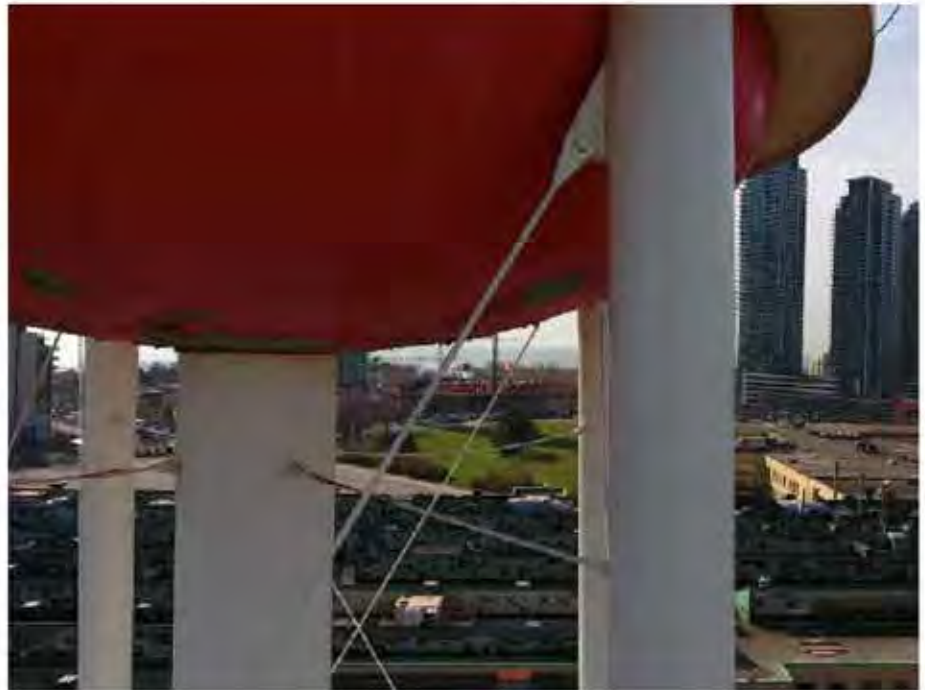
**PHOTOGRAPH NO. 5**

- ▶ Photo ID: CSE005
- ▶ Horizontal Tie
- ▶ April 13, 2017
- ▶ Problem: Corrosion on Horizontal Ties

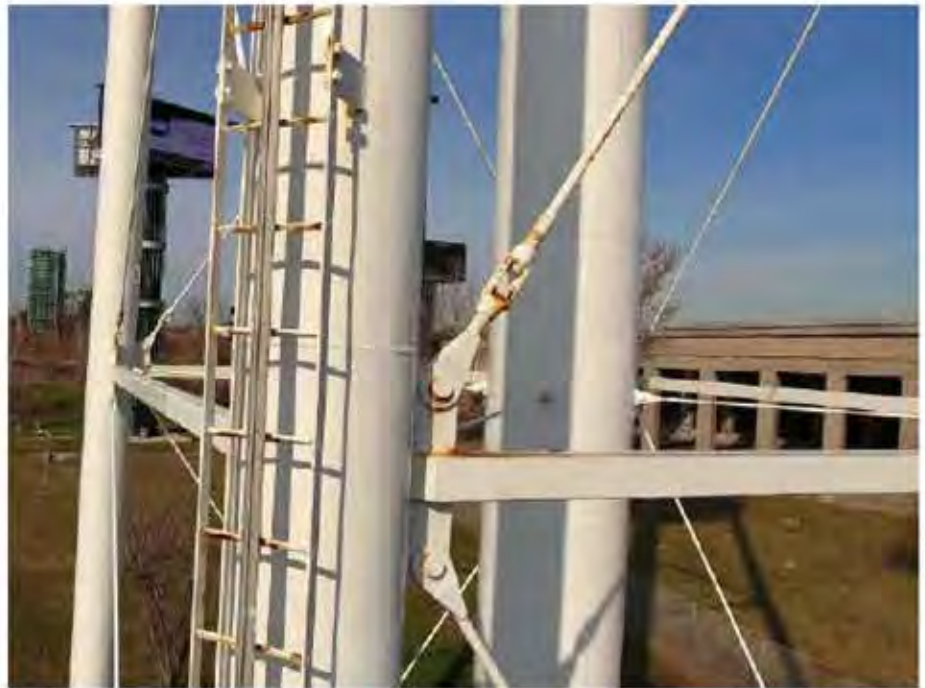
**PHOTOGRAPH NO. 6**

- ▶ Photo ID: CSE006
- ▶ Vertical Ladder
- ▶ April 13, 2017
- ▶ Problem: Corrosion on Ladder Rungs (Typical for Full Height)

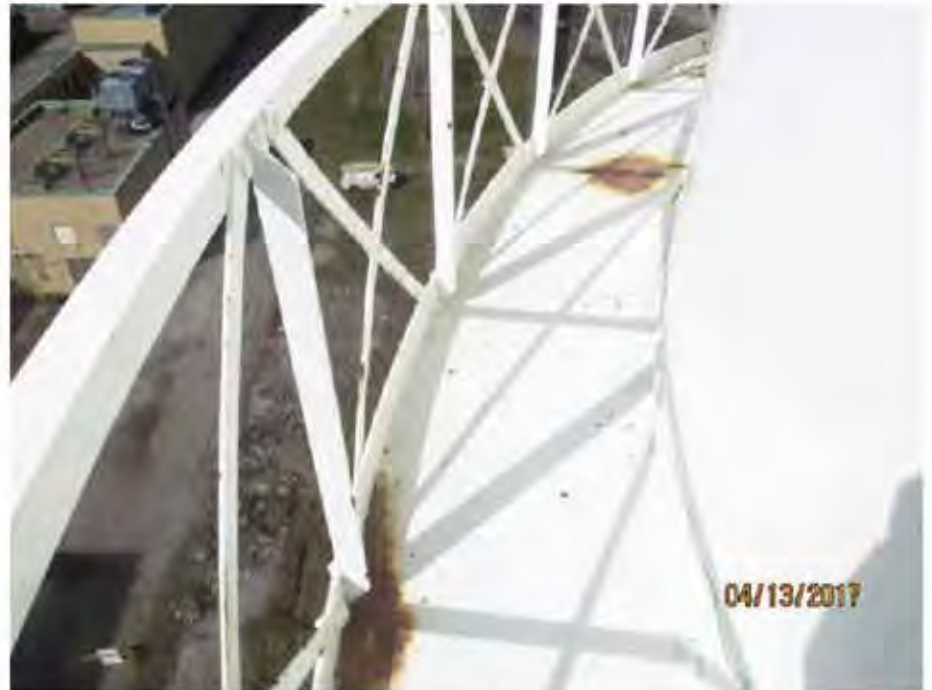
**PHOTOGRAPH NO. 7**

- ▶ Photo ID: CSE007
- ▶ Catwalk
- ▶ April 13, 2017
- ▶ Problem: Corrosion on Steel Deck

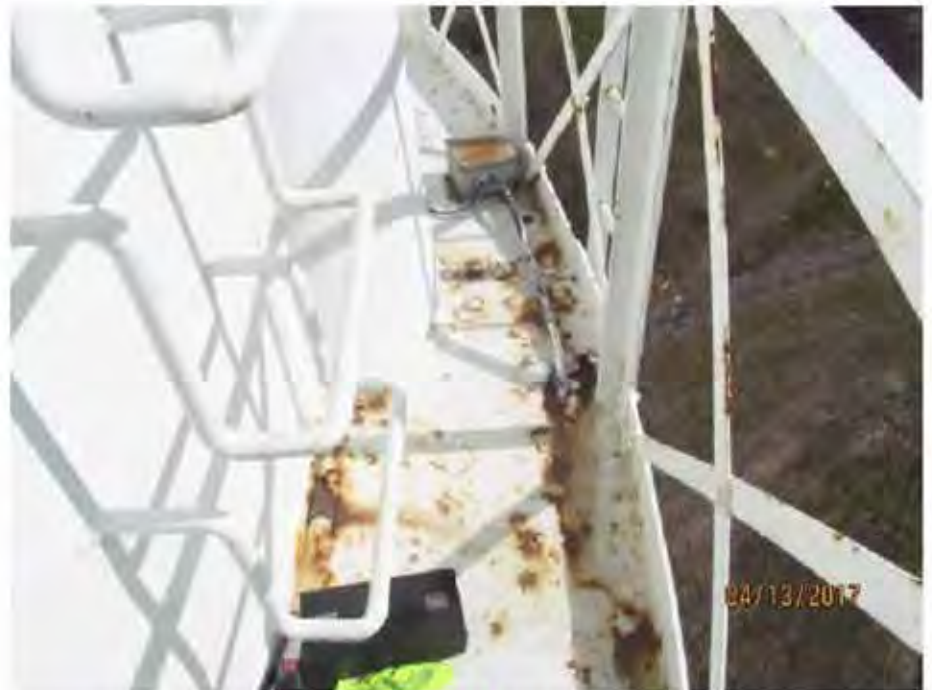
**PHOTOGRAPH NO. 8**

- ▶ Photo ID: CSE008
- ▶ Catwalk
- ▶ April 13, 2017
- ▶ Problem: Corrosion on Steel Deck & Peeling Paint

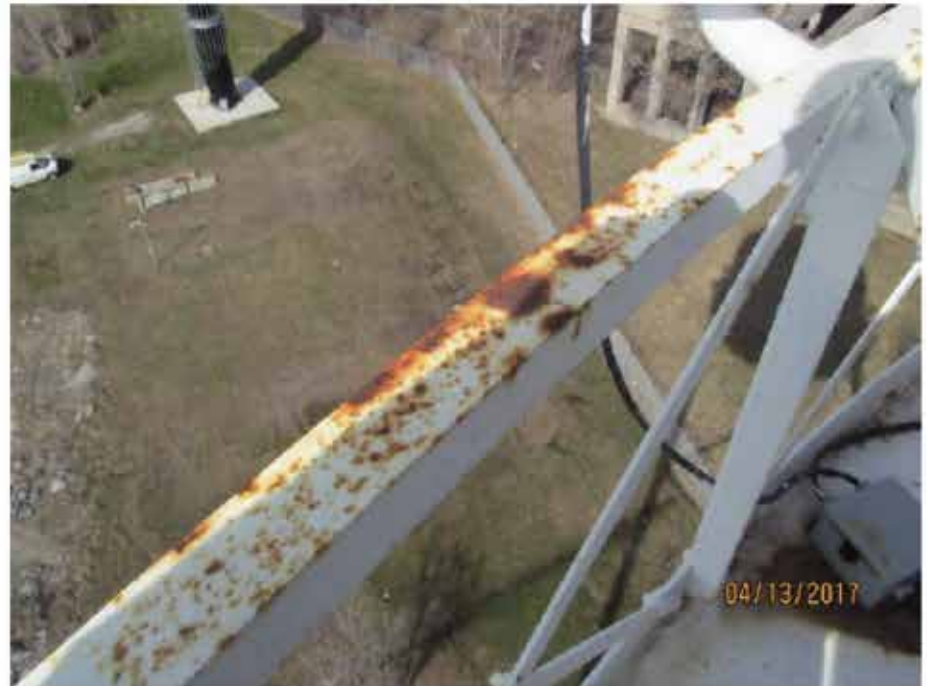
**PHOTOGRAPH NO. 9**

- ▶ **Photo ID: CSE009**
- ▶ **Guards**
- ▶ **April 13, 2017**
- ▶ **Problem: Corrosion on Handrail and other Components of Guard**

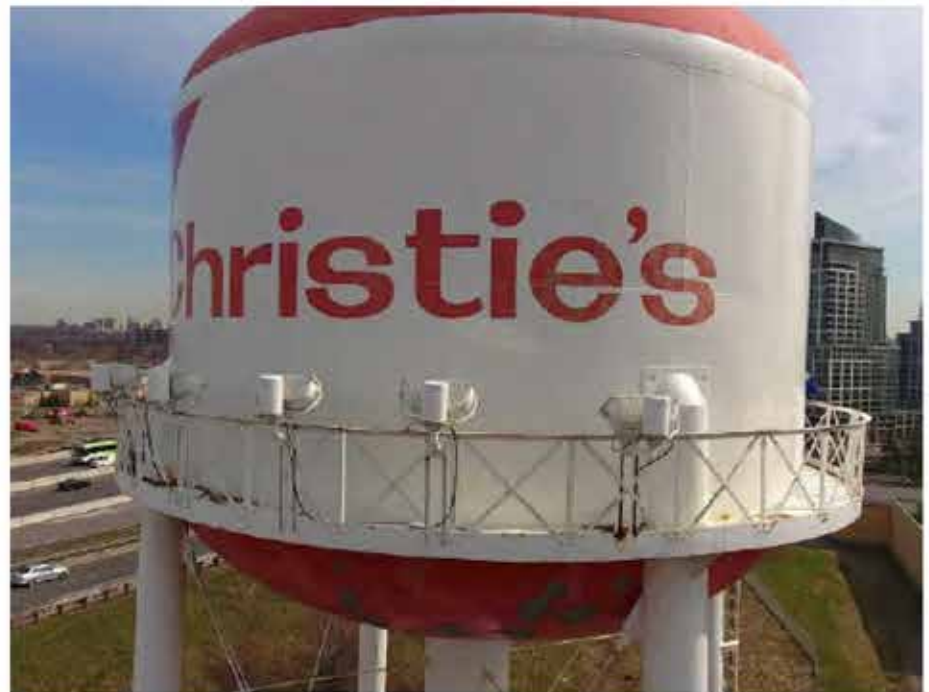
**PHOTOGRAPH NO. 11**

- ▶ Photo ID: CSE011
- ▶ Tank
- ▶ April 13, 2017
- ▶ Problem: Peeling Paint on Underside of Tank

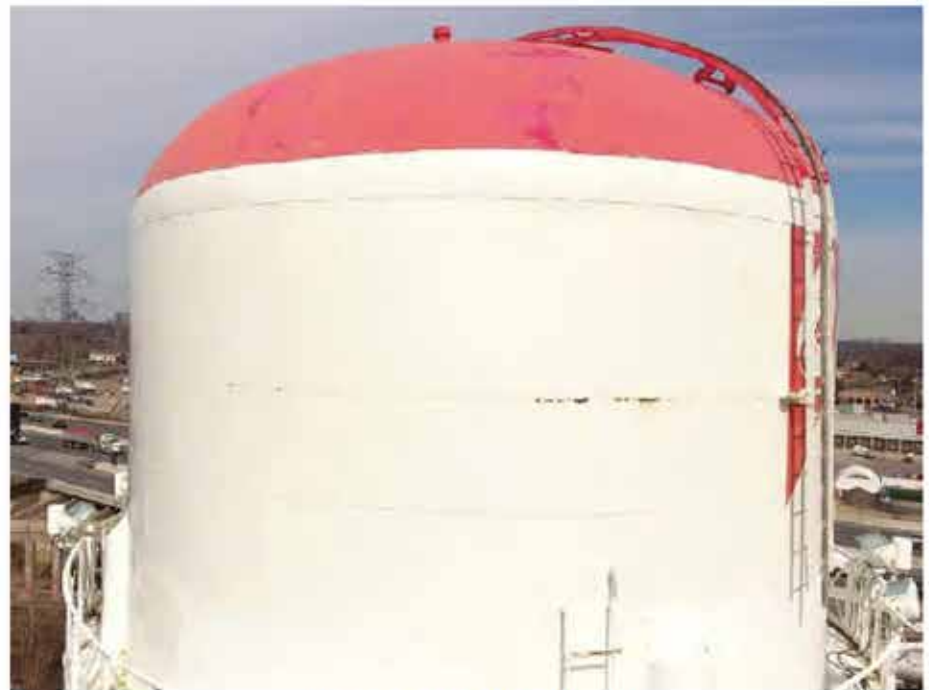
**PHOTOGRAPH NO. 12**

- ▶ Photo ID: CSE012
- ▶ Tank
- ▶ April 13, 2017
- ▶ Problem: Corrosion Along Second Line of Welds

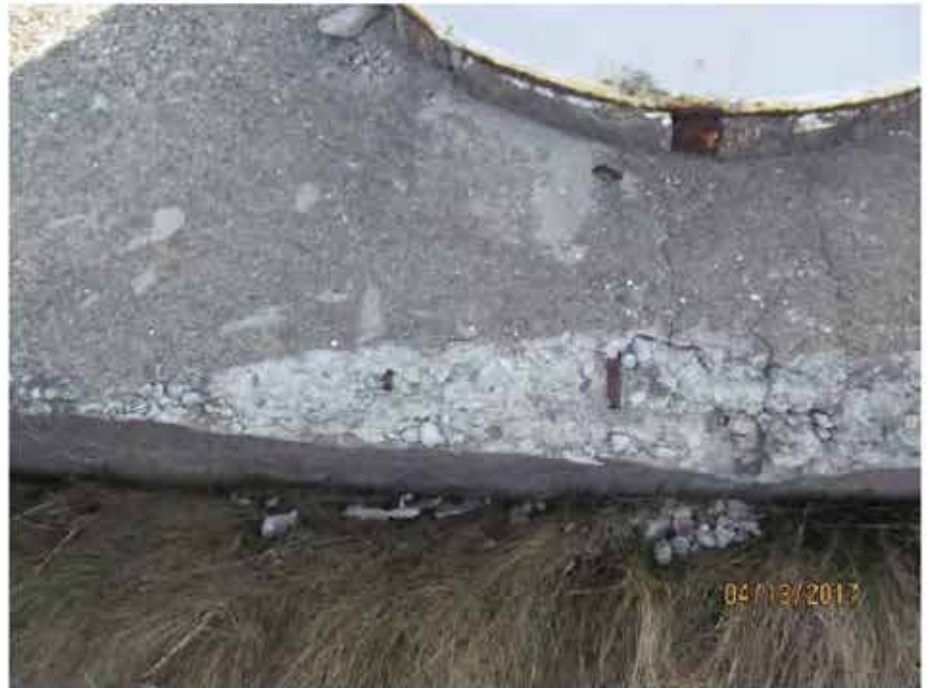
**PHOTOGRAPH NO. 13**

- ▶ **Photo ID: CSE013**
- ▶ **Concrete Slab**
- ▶ **April 13, 2017**
- ▶ **Problem: Concrete Spalling and Exposed Rebar**

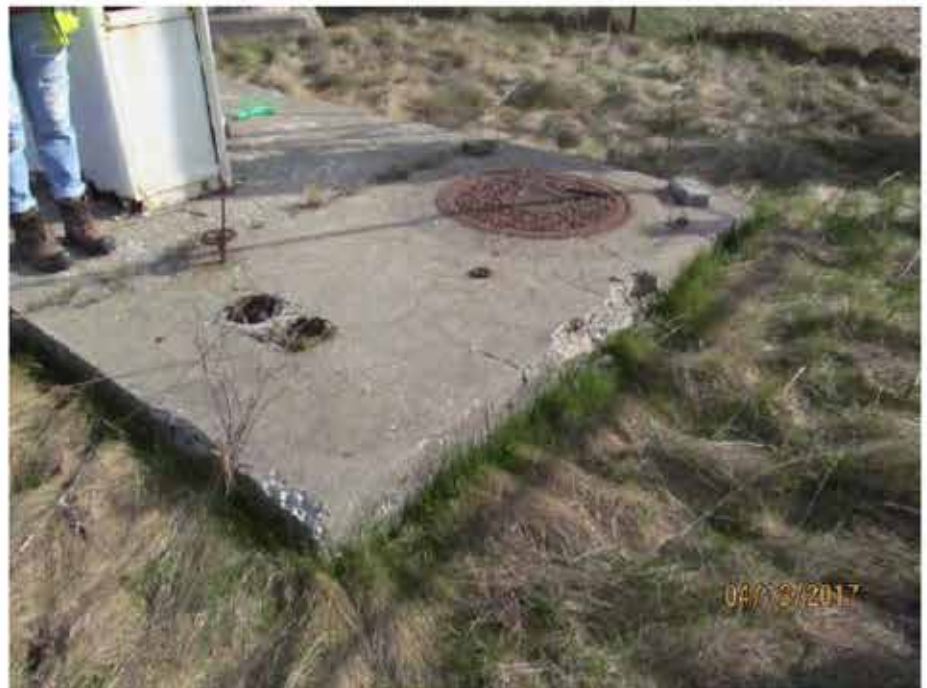
**PHOTOGRAPH NO. 14**

- ▶ **Photo ID: CSE014**
- ▶ **Concrete Slab**
- ▶ **April 13, 2017**
- ▶ **Problem: Concrete Spalling & Cracking**
