Tree Inventory Plan

**Lakeshore Development Inc.
Park Lawn GO Station
Tree Inventory Plan**

The Tree Preservation Plan, Figure B, Sheets 1 to 3, located in Appendix B, was prepared based on the preliminary design, showing existing conditions and property limits, including the railway corridor, footprints of adjacent buildings, fences, roads and tree locations. The plans prepared display:

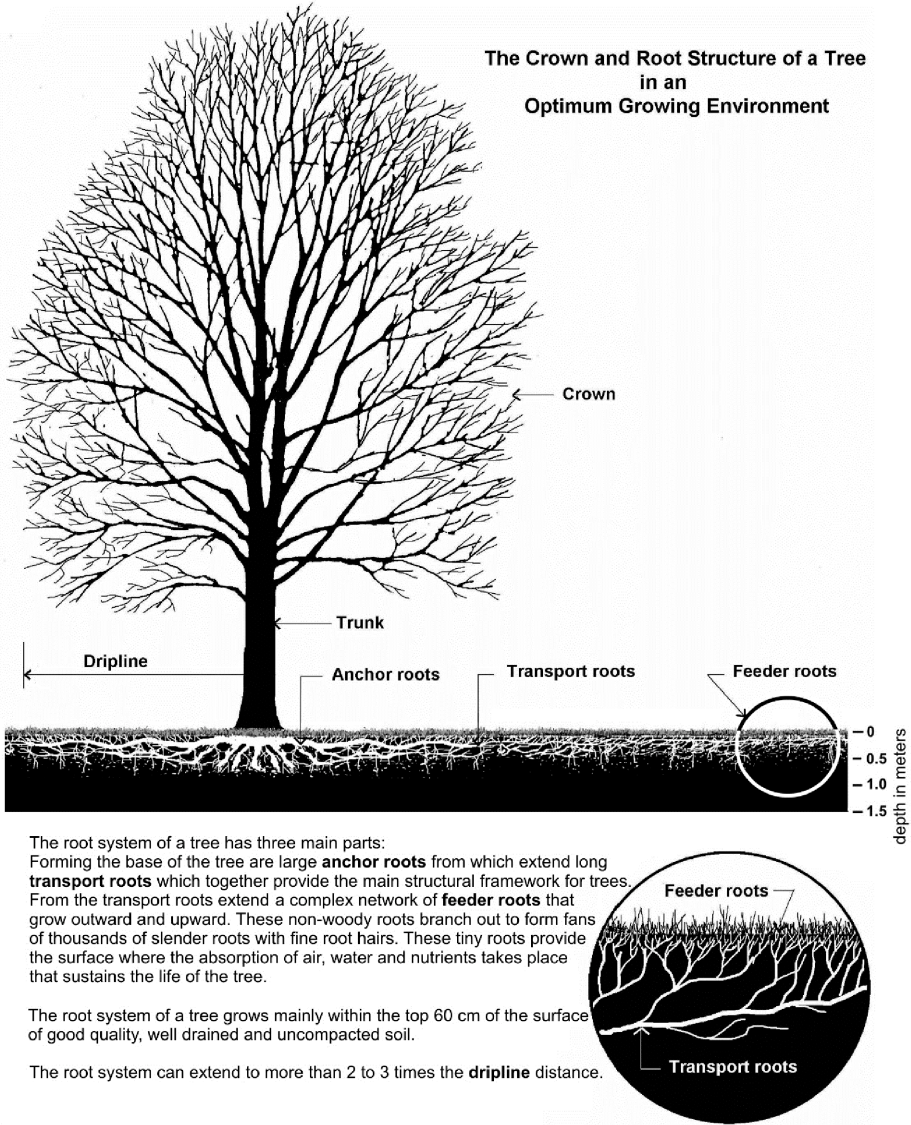
Figure: D Page: 1 of 3

The root system of a tree has three main parts: Forming the base of the tree are large **anchor roots** from which extend long **transport roots** which together provide the main structural framework for trees. From the transport roots extend a complex network of **feeder roots** that grow outward and upward. These non-woody roots branch out to form fans of thousands of slender roots with fine root hairs. These tiny roots provide the surface where the absorption of air, water and nutrients takes place that sustains the life of the tree.

The root system of a tree grows mainly within the top 60 cm of the surface of good quality, well drained and uncompacted soil.

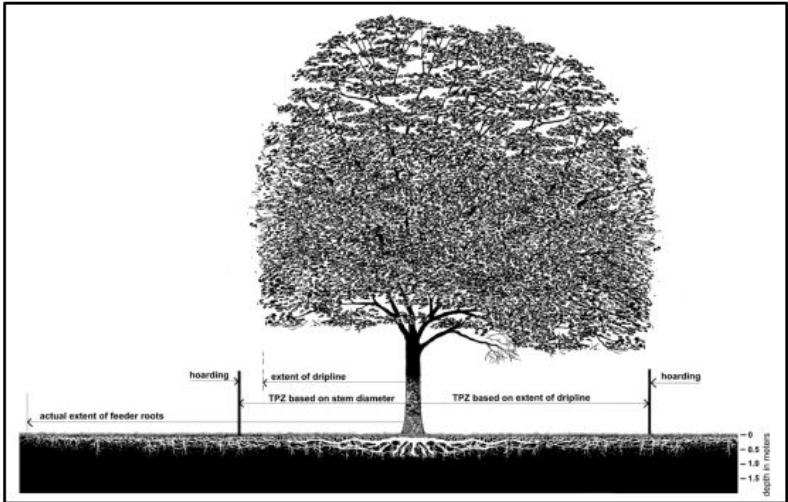
Figure 2: Minimum Tree Protection Zone (TPZ) Determination

⁵Converted from ISA Arborists' Certification Study Guide, general guideline for tree protection barriers of 1 foot of diameter from the stem for each inch of stem diameter.

The diagram below shows how the TPZ is determined:

In some cases, disturbances in the TPZ may be unavoidable, in which case, the TPZ must be adjusted in consultation with the arborist and Urban Forestry. In these situations, it may be necessary to implement other tree protection measures such as horizontal root protection as noted in section 3 of this document.
