Draft Slope Stability Analysis

Park Lawn GO Station

Slope Stability Analysis

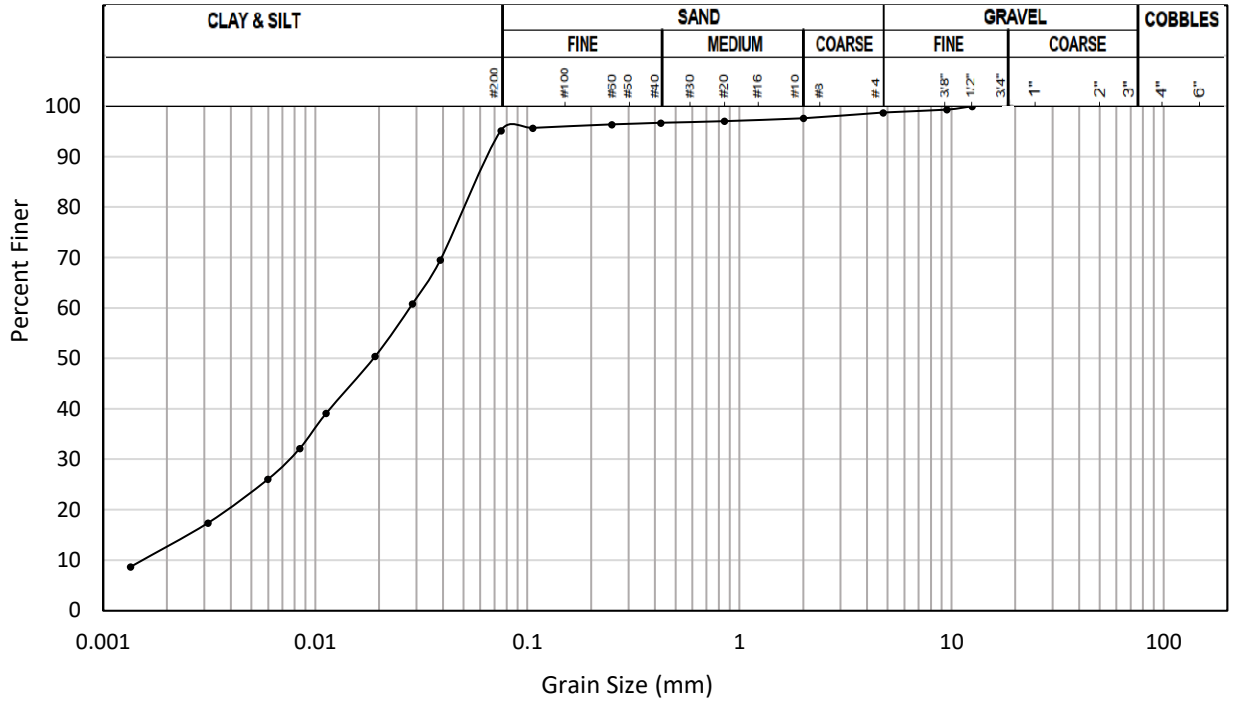
Sample	SS8	**Depth**	6.10 to 6.71 m
Source	BH21-S5

Comments: Material is shaley. Slakes after washing and drying.

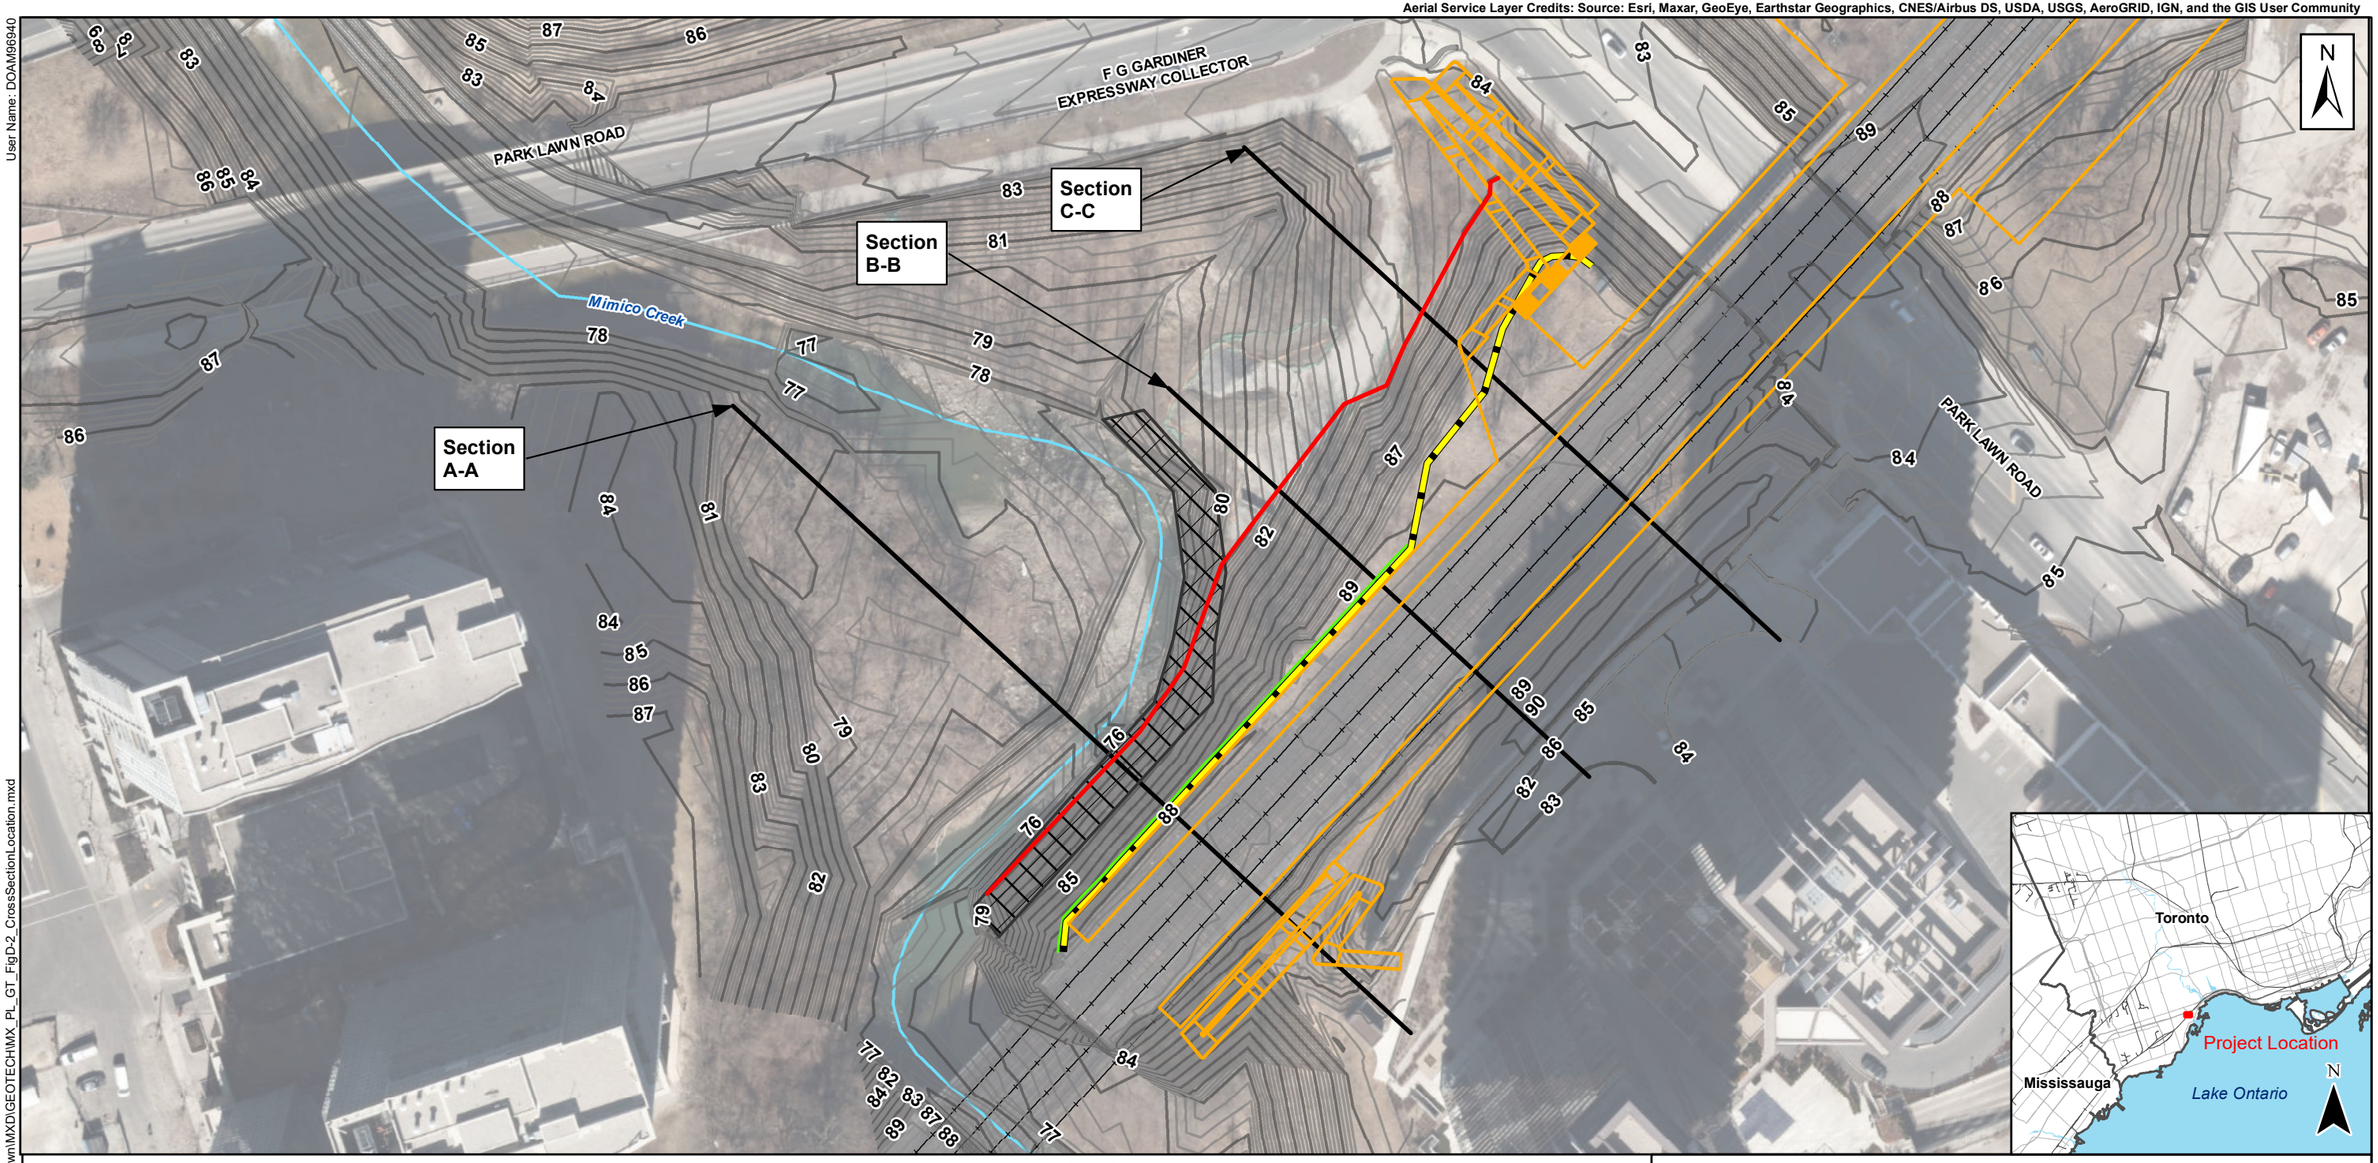
Project:	**Park Lawn GO Station**		
Figure Title:	**Cross-Sections Location**		
Prepared By: HATCH		**Date:** August 27, 2021	
Version: PL.GT.100-1	**Review:**	**Figure:** D-1	**Page:** 1 of 1

The existing conditions at the TRCA regulated lands, as described above and indicated on Figure 1-1, were taken from the available topographic survey data received on February 23, 2021, as shown on Figure D-1. The latest topographic survey provides coverage of not only the existing rail tracks, but also extends to the north to provide topographic data for the remainder of the slopes, the retaining wall at the base of the slopes and the creek channel. The data also provides further detail of the eastern portion of the slopes where there is a flat lying area between the slope and the creek.

Three cross sections were selected for analysis at the locations shown on Figure D-1. The cross sections, were imported into Slope/W so that the slope could be used to develop the geometry for each section. The slope geometry was smoothed out to simplify the geometry so that the geometry would not cause irregularities with the slope stability assessment of each section.

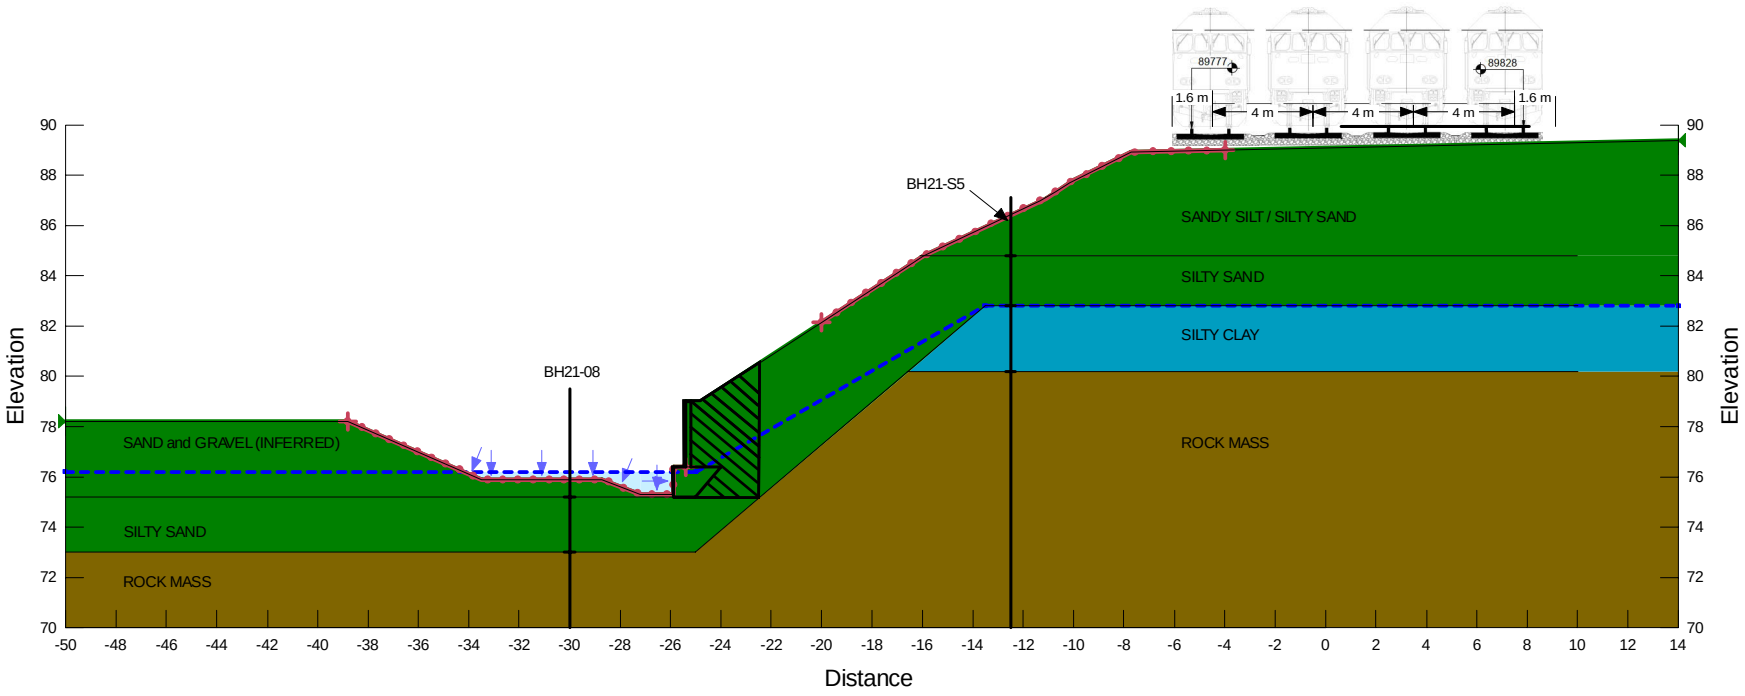
0+034 - Existing Conditions - Definition	
SLOPE/W - Morgenstern-Price (Minimum Slip Surface Depth: 1 m)	
TRCA Lands Slope Stability Assessment	FIGURE D-3

The slope stability model geometry, for the existing conditions, is shown on Figures D-3 to D-5.

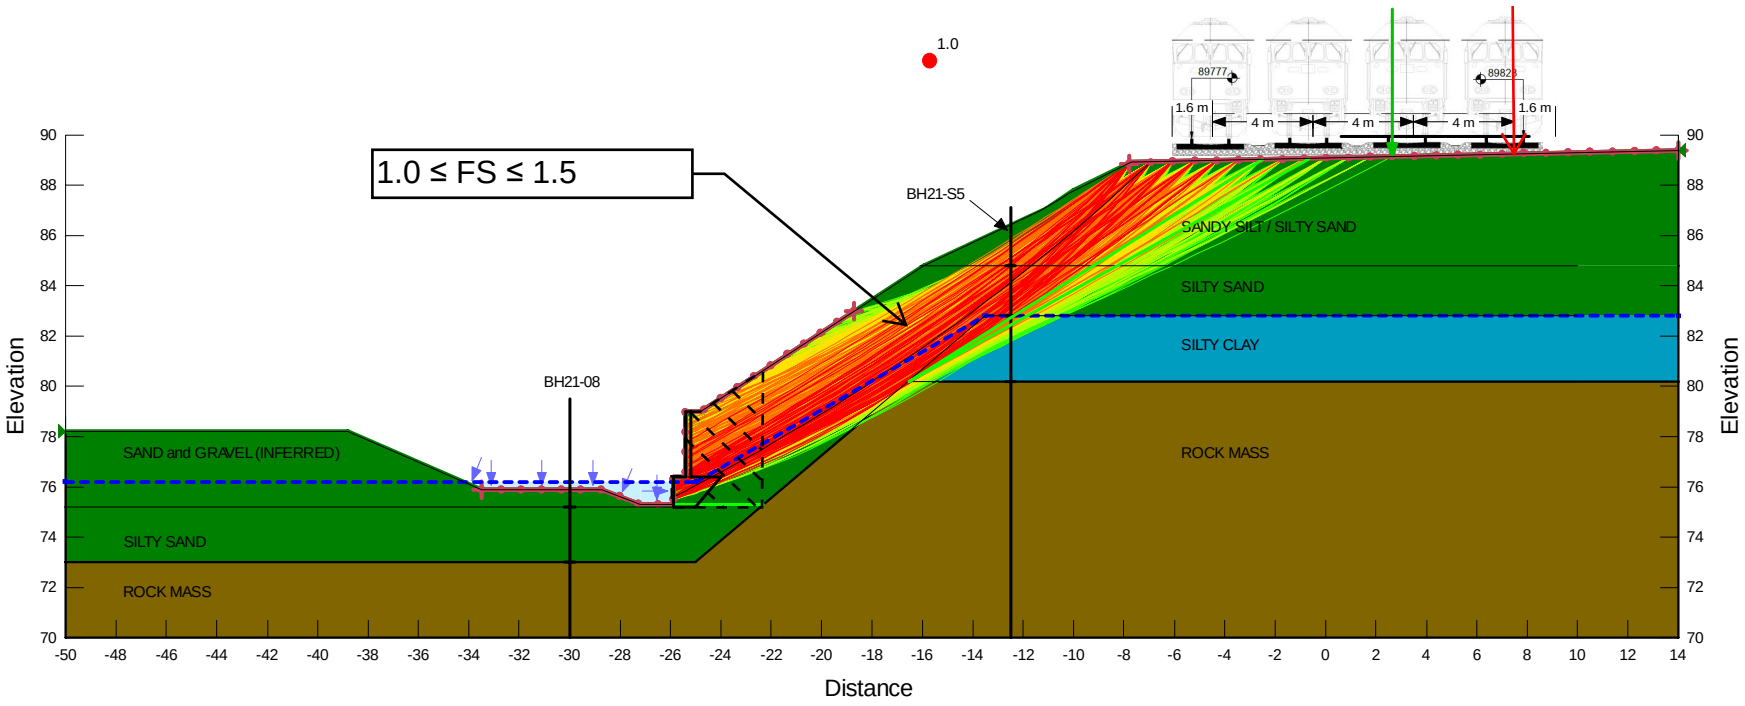
Section 0+034 (A-A'): Figure D-8 illustrates slip surfaces ranging from 1.0 ≤ FS ≤ 1.5. Results for the existing slope conditions indicate that the slope has an FS ≅ 1.0, shown on Figure D-8, which is lower than the industry accepted minimum FS of 1.5 for slope stability. The LTSTOS is taken as the slip surface that has a surface projection the furthest from the crest of the slope, as indicated on Figure D-8 by the vertical green arrow. A minimum set-back of 5 m is indicated by the vertical red arrow, which is a further allowance for the potential toe erosion due to Mimico Creek.

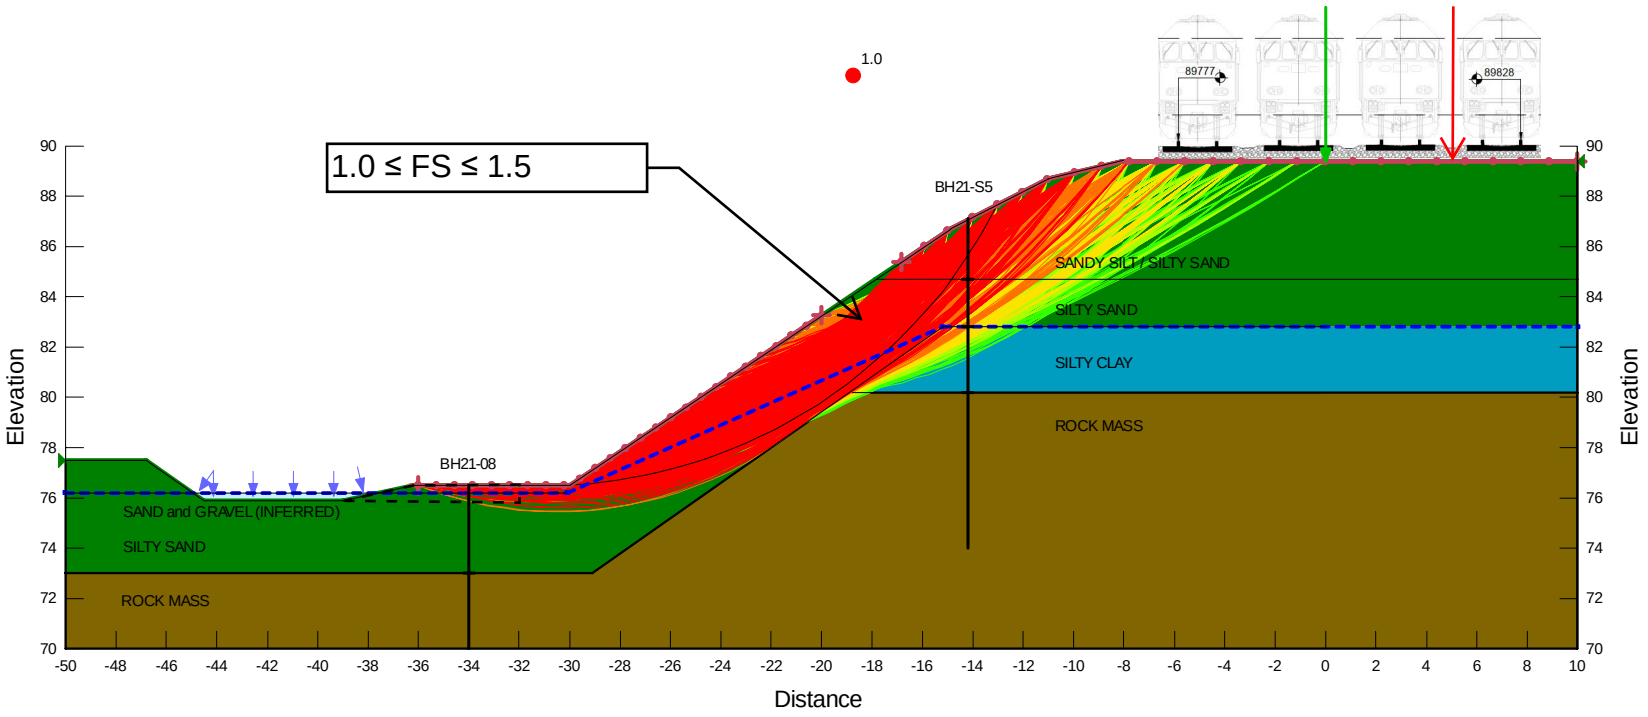
Section 0+086 (B-B'): Figure D-9 illustrates slip surfaces ranging from 1.0 ≤ FS ≤ 1.5. Results for the existing slope conditions indicate that the slope has an FS ≅ 1.0, shown on Figure D-9, which is lower than the industry accepted minimum FS of 1.5 for slope stability. The LTSTOS is taken as the slip surface that has a surface projection the furthest from the crest of the slope, as indicated on Figure D-9 by the vertical green arrow. A minimum set-back of 5 m is indicated by the vertical red arrow, which is a further allowance for the potential toe erosion due to Mimico Creek; it is provided for reference purposes only given that Mimico Creek is not expected to affect this section of the slope.
