APPENDIX I Slope Stability Analysis

Lakeshore Development Inc. Park Lawn GO

Slope Stability Analysis

Lakeshore Development Inc. - Park Lawn GO Slope Stability Analysis

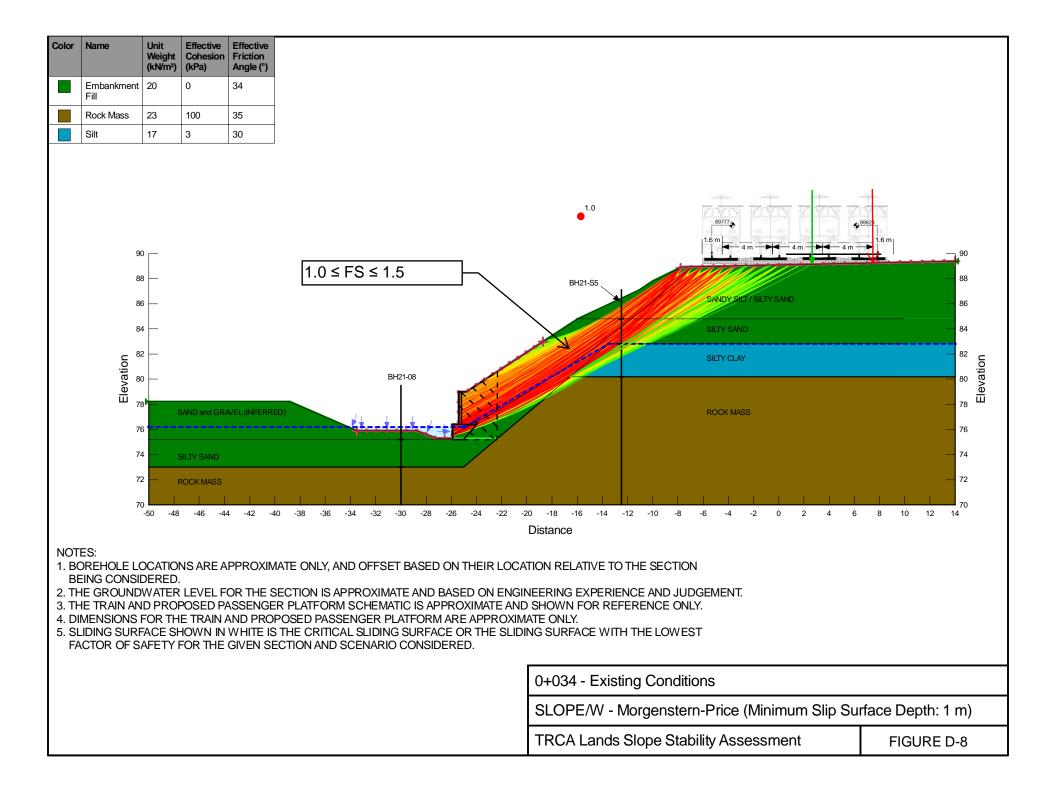
<u>Section 0+034 (A-A')</u>: Figure D-8 illustrates slip surfaces ranging from $1.0 \le FS \le 1.5$. Results for the existing slope conditions indicate that the slope has an FS \cong 1.0, shown on Figure D-8, which is lower than the industry accepted minimum FS of 1.5 for slope stability. The LTSTOS is taken as the slip surface that has a surface projection the furthest from the crest of the slope, as indicated on Figure D-8 by the vertical green arrow. A minimum set-back of 5 m is indicated by the vertical red arrow, which is a further allowance for the potential toe erosion due to Mimico Creek.

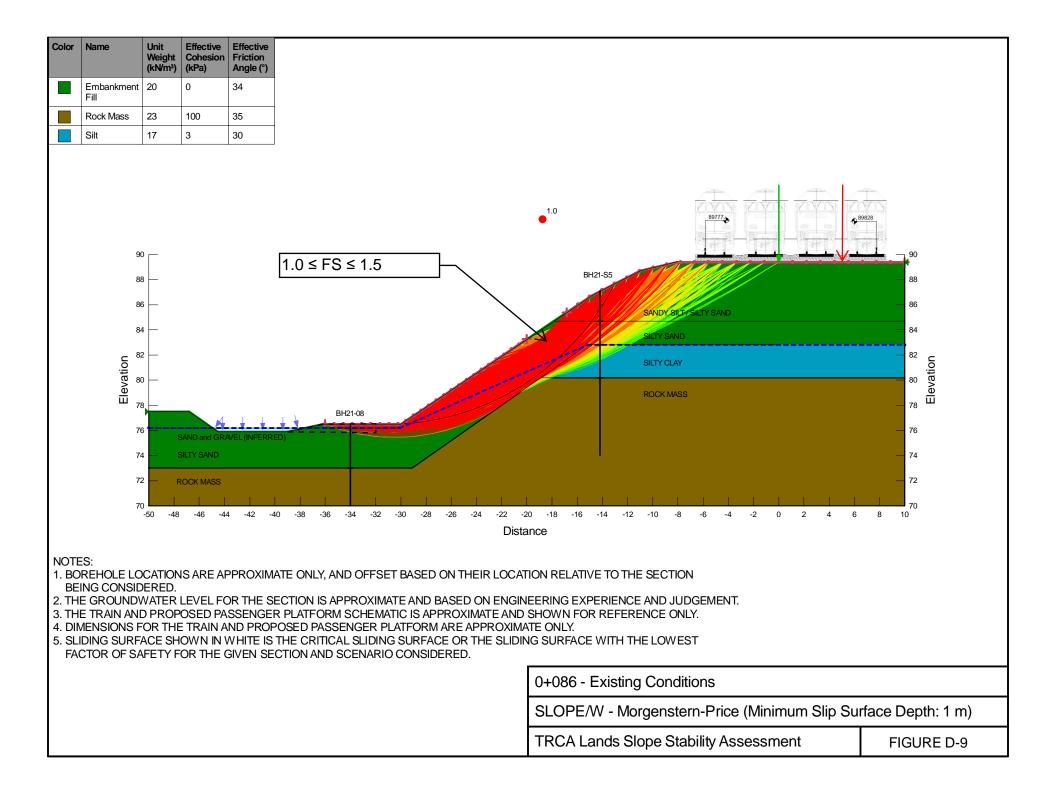
Section 0+086 (B-B'): Figure D-9 illustrates slip surfaces ranging from $1.0 \le FS \le 1.5$. Results for the existing slope conditions indicate that the slope has an FS \cong 1.0, shown on Figure D-9, which is lower than the industry accepted minimum FS of 1.5 for slope stability. The LTSTOS is taken as the slip surface that has a surface projection the furthest from the crest of the slope, as indicated on Figure D-9 by the vertical green arrow. A minimum set-back of 5 m is indicated by the vertical red arrow, which is a further allowance for the potential toe erosion due to Mimico Creek; it is provided for reference purposes only given that Mimico Creek is not expected to affect this section of the slope.
