FCR (Park Lawn) LP and CPPIB Park Lawn Canada Inc.

2150 Lake Shore Boulevard West

Rail Safety and Development Viability Assessment

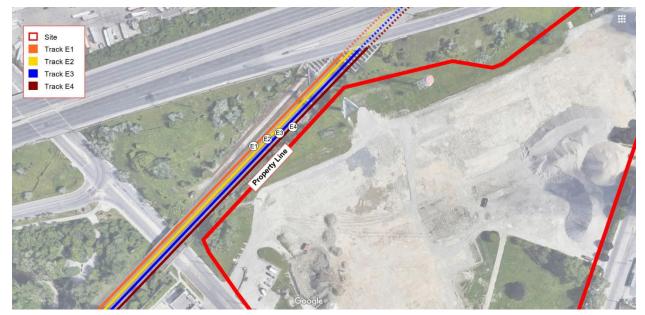
Figure 3-1 – Satellite Aerial of Site Conditions along the Oakville Subdivision

Figure 3-1 below provides a general overview of the track alignment relative to the site.

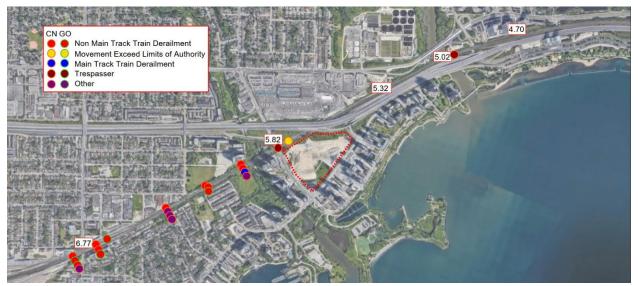
Figure 4-1 below identifies train incidents by the location and associated rail operator within a 1-mile radius of the site. As is evident by the absence of main track derailments and collisions involving Metrolinx trains, Metrolinx maintains a very safe operating environment.

All CN-related incidents occurred prior to Metrolinx ownership and incidents involving this rail operator have not been recorded since Metrolinx took over the line.
