Project No. 1669657

RE: MAY 2020 ENVIRONMENTAL CONDITION, MANAGEMENT APPROACH AND STATUS UPDATE, FORMER CHRISTIE COOKIE MANUFACTURING FACILITY, 2150 AND 2194 LAKESHORE BOULEVARD WEST, TORONTO, ON

2150 LAKE SHORE BOULEVARD WEST, TORONTO, ONTARIO

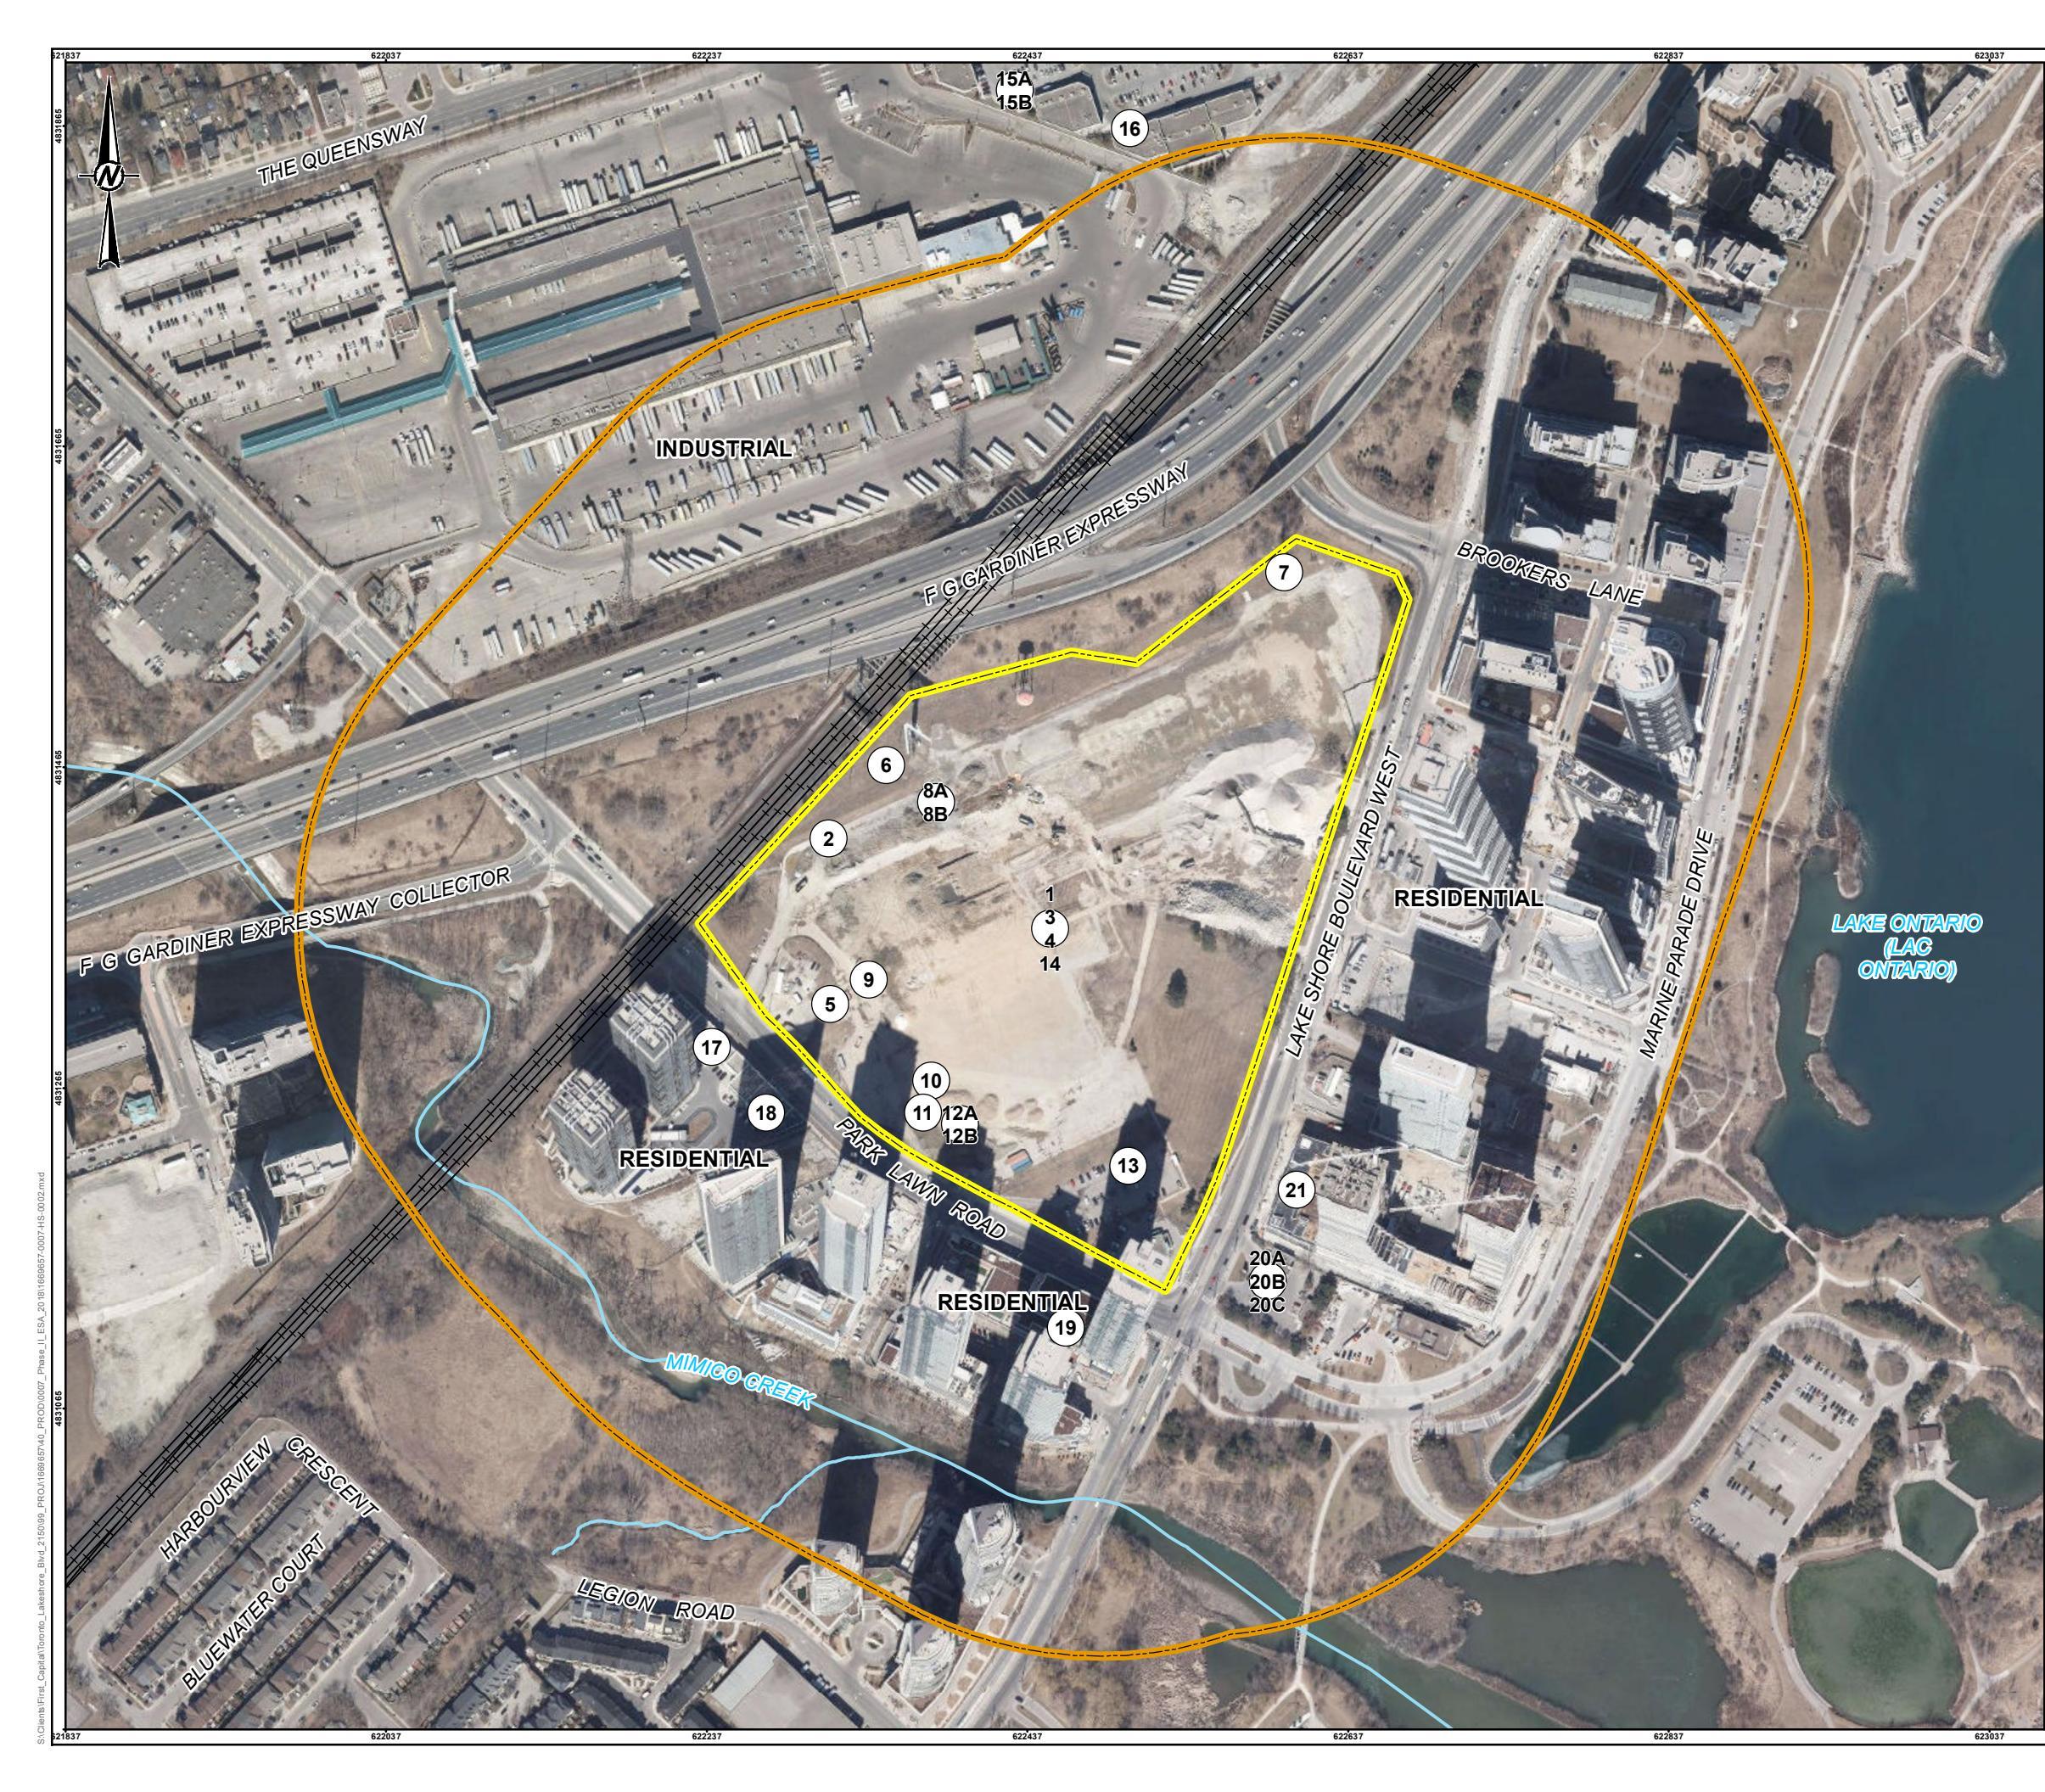
YYYY-MM-DD		2020-05-01	
DESIGNED		EC	
PREPARED		JT/SFC	
REVIEWED		EC	
APPROVED		EH	
	REV.		FIGURE
	А		1

POTENTIALLY CONTAMINATING ACTIVITIES

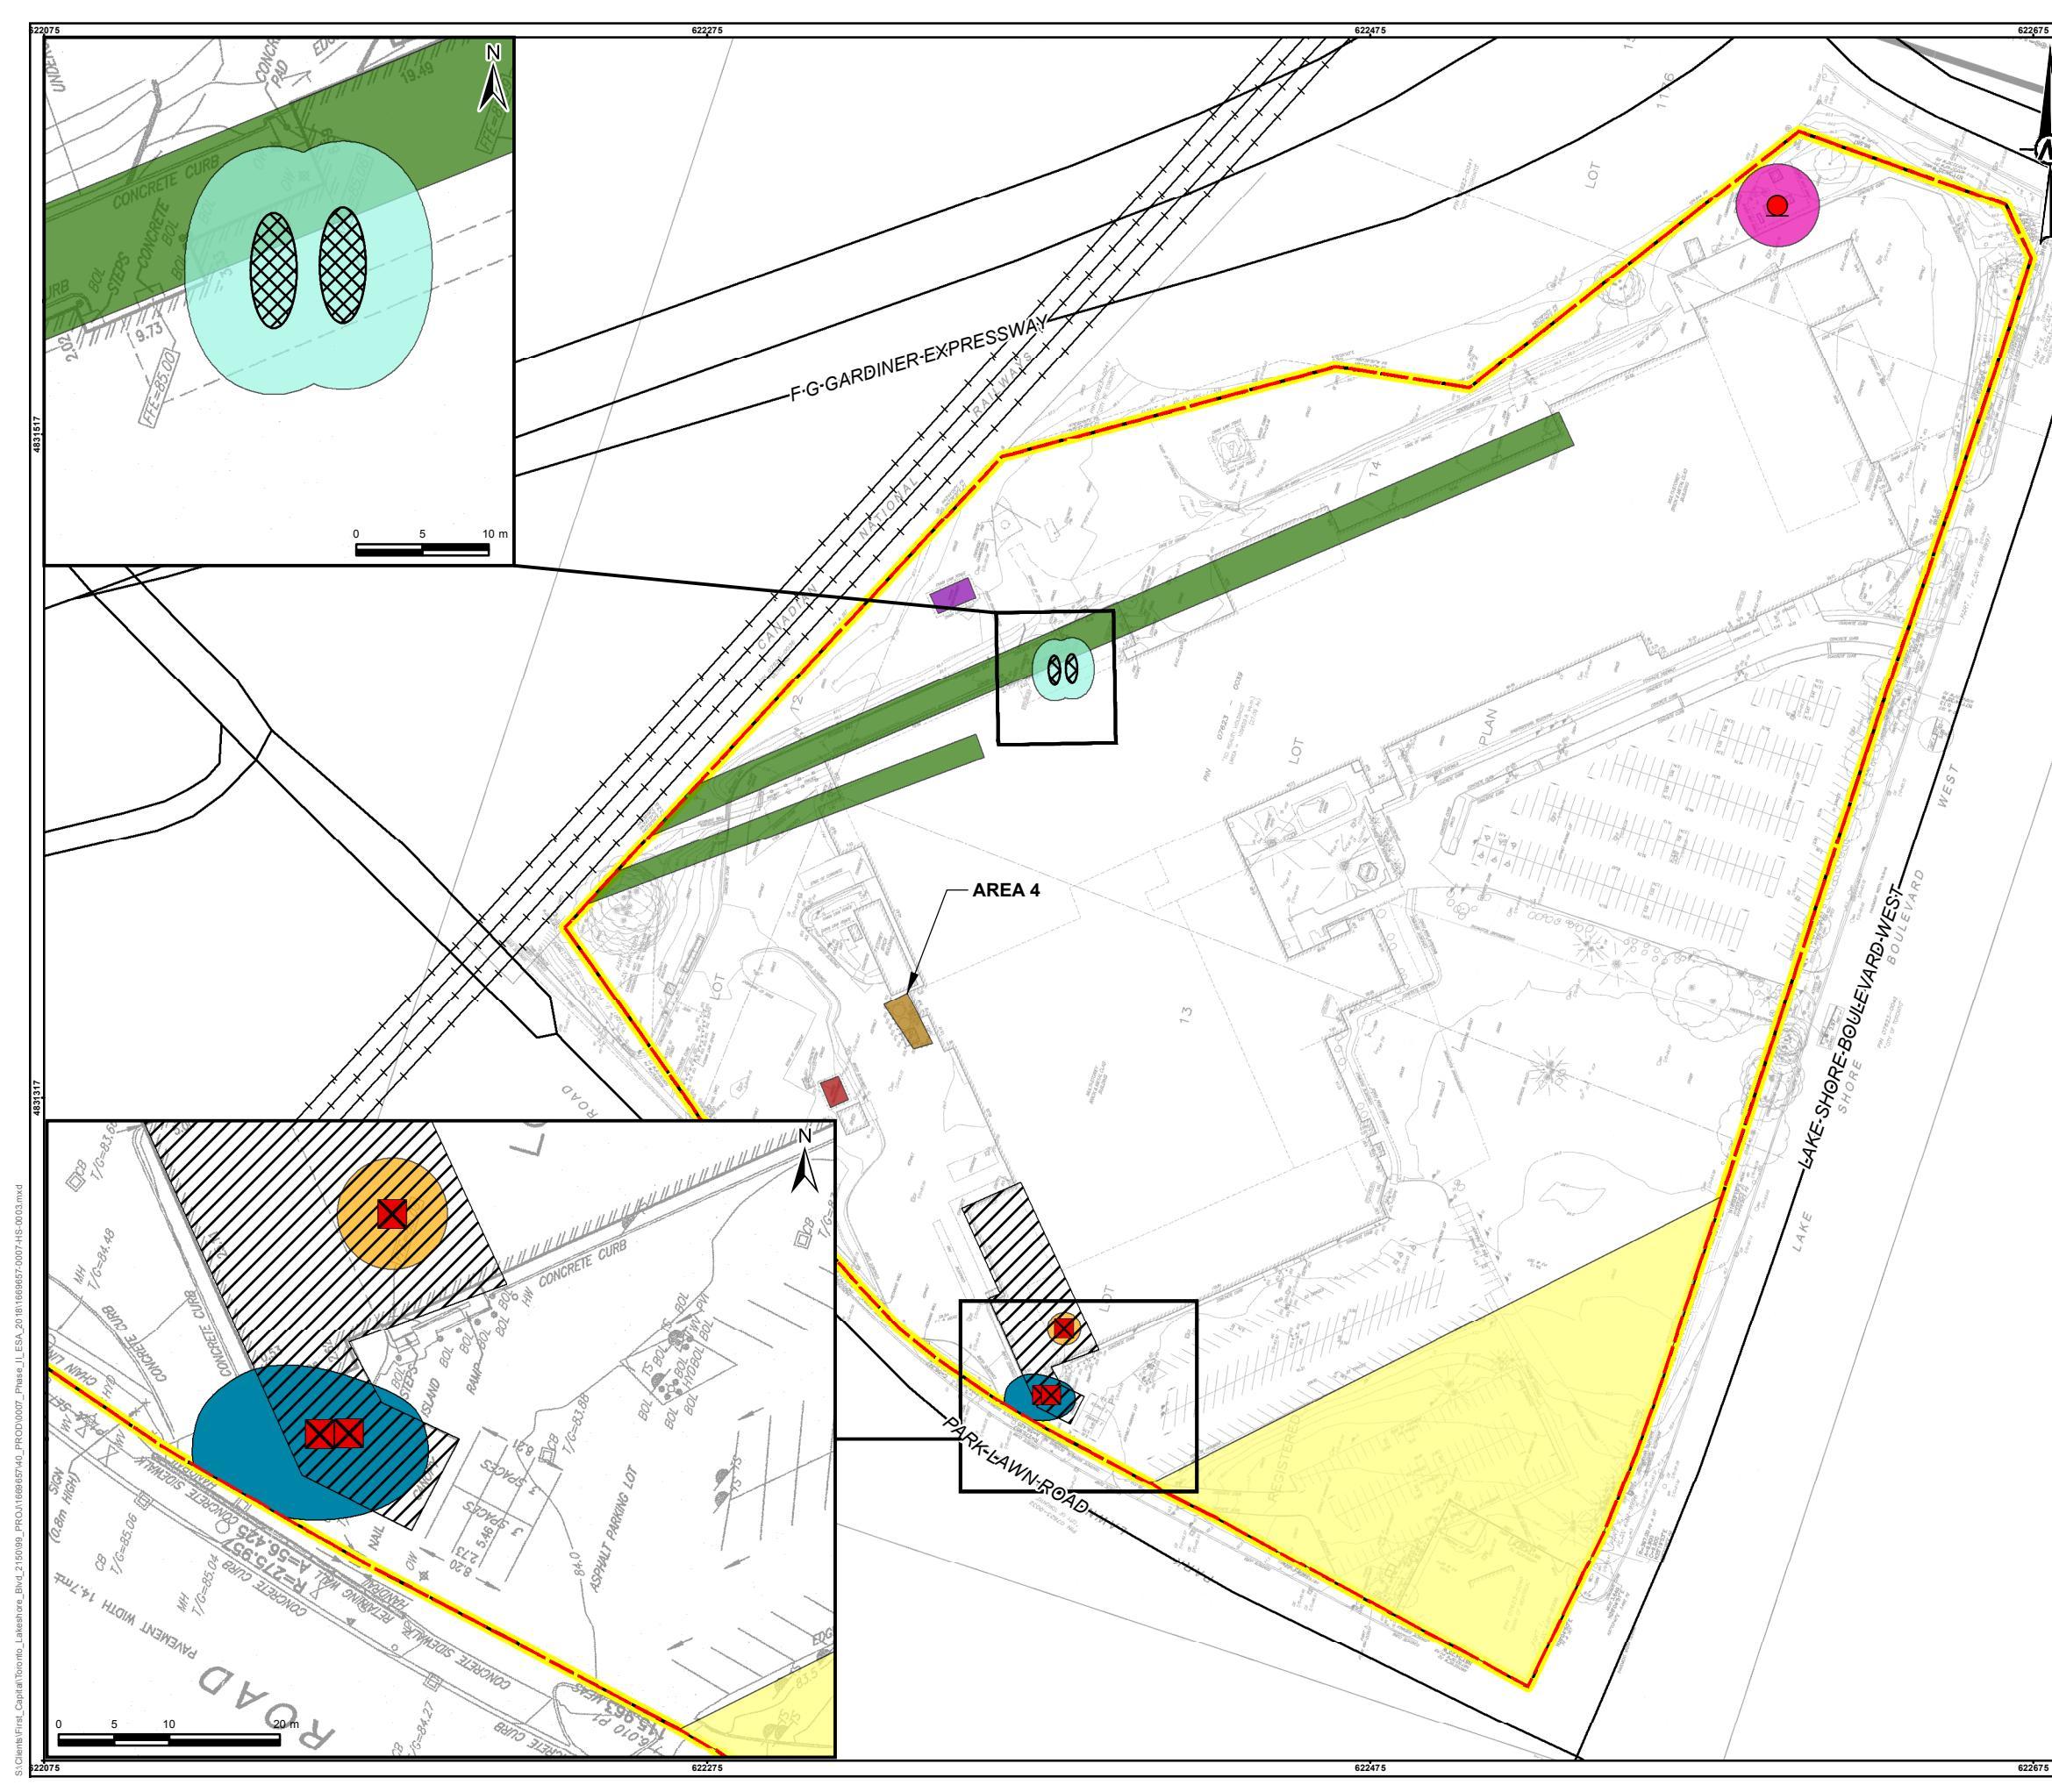
-			DESIGNED	KT		
	🚺 G	OLI) E R	REVIEWED	J1/SF		
				APPROVED	EH		
	PROJECT NO.	CONTRO	OL	F	REV.	FIGURE	
	1 669657	0007		A	A	2

483	14	APPLICATION	OF DE-ICING SALT OF	E N-SITE		
		ļ			i		
		0		50	100		
		1:2,00	00	METRES			
	NOTE(S)						
	1. ALL LOCATIONS A	RE APPROX	IMATE				
	BASE DATA - MNR LIC	, OBTAINED 2	2016				
	RESOURCES, © QUE	ENS PRINTER	2019		N TARIO MINIS	TRY OF NATURAL	
	PROJECTION: TRANS	VERSE MERC	CATOR DATUM	: NAD 83 COORDIN	NATE SYSTEM	UTM ZONE 17N	
	CLIENT						
	FIRST CAPITA	AL ASSE	r managi	EMENT LP			
	PROJECT						
	2150 LAKE SHORE BOULEVARD WEST, TORONTO, ONTARIO						
	AREAS OF P	OTENTIA		ONMENTAL (CONCER	N	
	CONSULTANT			YYYY-MM-DD	2020-0)5-01

and storage activities; historic on-Site vehicle servicing activities; historic presence of rail spurs; and historic presence of electrical transformers at the Site as areas of potential environmental concern ("APEC"). The APEC and the associated affected areas of the Site are shown on Figure 2.

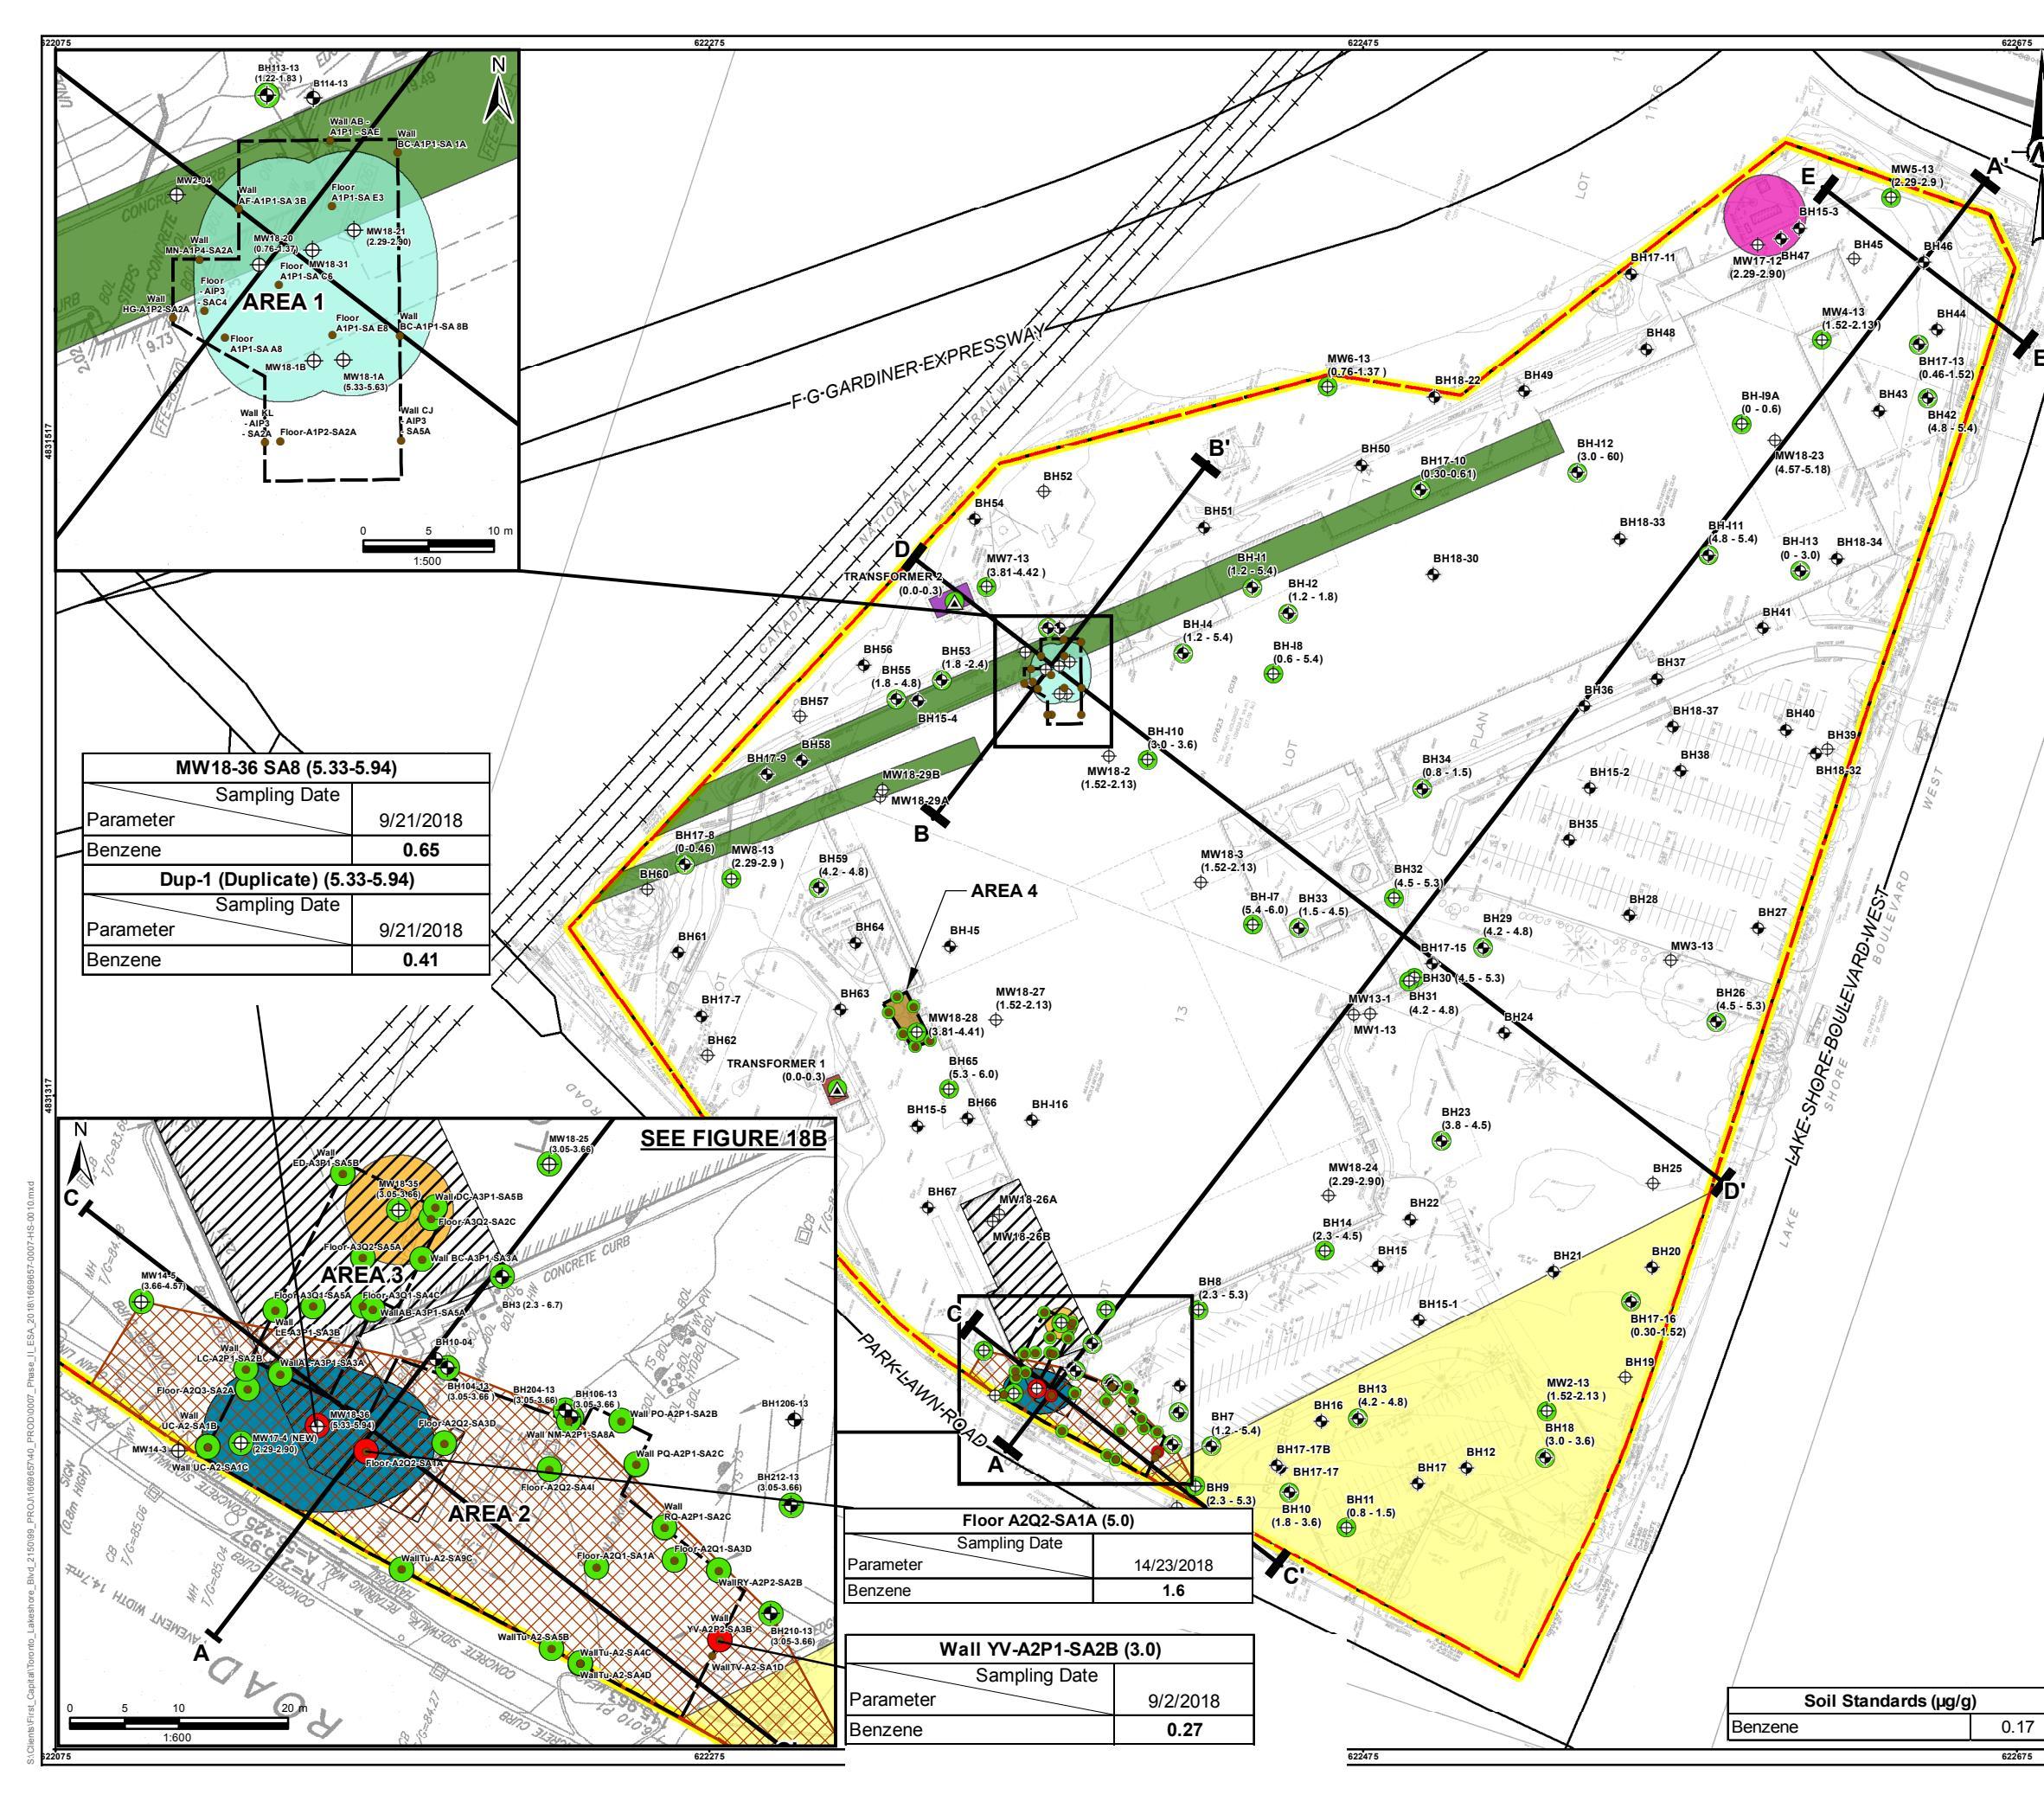
- <u>.</u>					3

BASE P PROJEC	LAN PROVIDED B CTION: TRANSVEF	Y STANTEC G	EOMATICS, DATED APRI OR DATUM: NAD 83 CC	L 11, 2013 ORDINATE SY	STEM: UTM ZONE 17N		
FIRS	T CAPITAL	ASSET N	/IANAGEMENT L	P			
PROJE	СТ						
2150	LAKE SHO	RE BOU	LEVARD WEST,	TORONT	O, ONTARIO		
SOIL I	EXCEEDANCE REMEDIATIO	S - BENZI N	ENE, TOLUENE, ET	HYLBENZE	NE AND XYLENES		
CONSL	ILTANT		YYYY-MM-	DD 2	020-05-01		
			DESIGNED) k	π		
		חו) J	T/SFC		
			REVIEWE) <u>k</u>	ат <u>— — — — — — — — — — — — — — — — — — —</u>		
			APPROVE	D E	H		
PROJE	CT NO. 7	CONTROL 0007		REV. A	FIGUR

- Shallow fill material (up to 2 m below existing grade) primarily in the eastern portion of the Site that has not been excavated and removed from Site to date;
- Localized soil impacted by BTEX below the floor of the remedial excavation in the vicinity of MW18-36 (and associated floor verification sample A2G2-SA 1A) (see Figure 3); and,
- Localized soil impacted by fluoranthene around the perimeter of the remedial excavation in associated with the former Christie Cookie manufacturing plant in the vicinity of MW17-4 and YV-A2P2-SA2B (See Figure 4).

The locations of these residual soil concentrations are shown on Figures 3 and 4.

The RA also addresses the potential presence of residual volatile BTEX constituents (benzene) in soil within the localized areas shown on Figure 3 and the presence of residual fluoranthene in soil within the localized areas shown on Figure 4. However, it is anticipated that the identified residual impacts will either be removed from the Site to satisfy the SCS prior to redevelopment or will be addressed during redevelopment through removal or addressed through appropriate MECP-approved risk management measures.

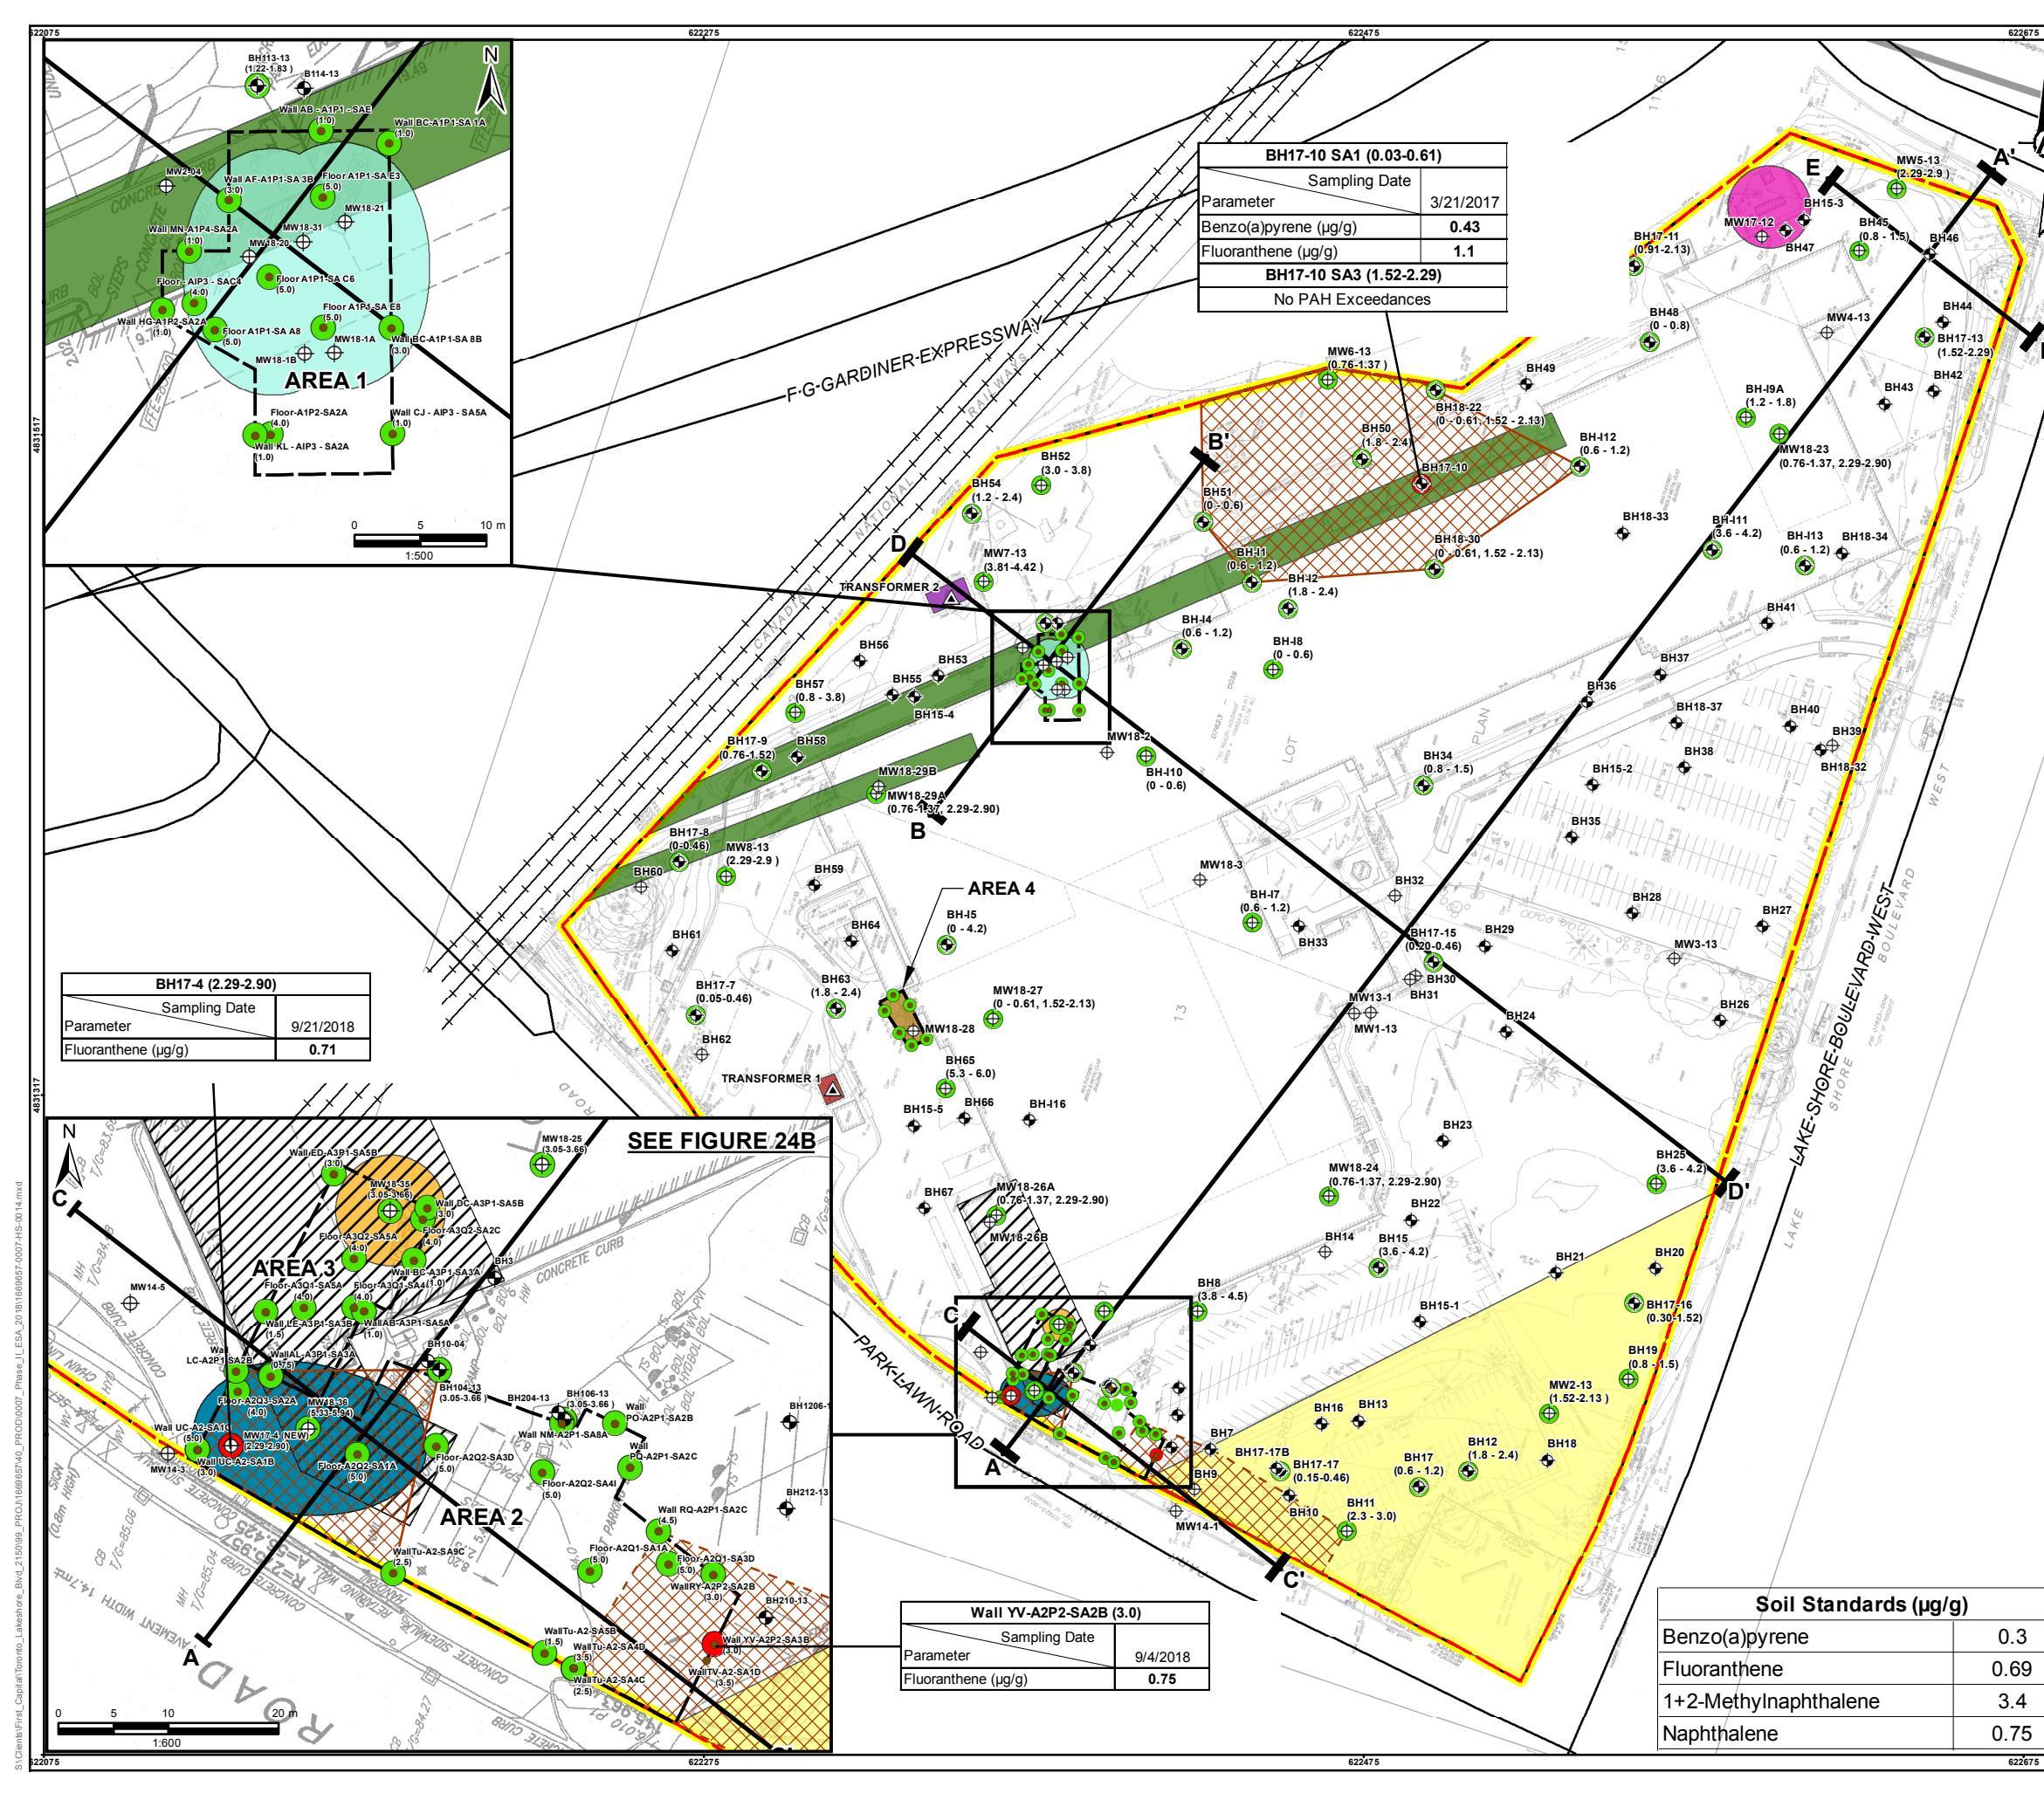
TITLE								
	SOIL	EXCE	EDANC	ES - PC	DLYCYCL	IC AROM	АТІС НҮ	DROCA	RBONS -
_	POST	-REME	DIATIO	ON					
	CONSU	LTANT				YYYY-MM-DD	:	2020-05-01	
11						DESIGNED		кт	
+1			GO		FD	PREPARED		JT/SFC	
+						REVIEWED		кт	
\downarrow						APPROVED	l	EH	
		CT NO.	C	ONTROL			REV.		FIGURE
-+ 1	. <u>⊊</u> 1669657	,		JU07			A		4
